by Larry Frash

Familiar Failures and Faithful Fixes for the Mazda FN4A-EL and Ford 4F27E

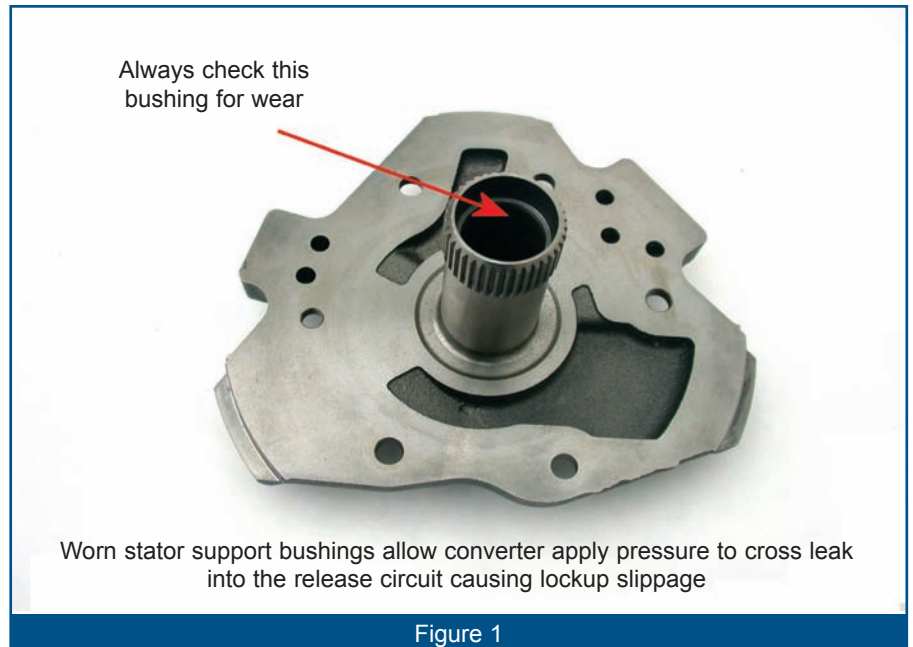
Figure 1

The stator support bushings support the turbine shaft (figures 1 and 2), but they also separate the TCC apply and release pressures. With lockup released, converter charge pressure is delivered between the converter clutch and the apply surface (the front converter cover). This hydraulic pressure is called *converter release pressure*, and that pressure is what keeps the converter clutch from applying.

When the stator support bushings are worn, they can allow converter apply pressure to leak into the release side of the converter. When this occurs,

converter release pressure can't exhaust fast enough, so it keeps pressure on the release side of the converter clutch. This prevents the converter clutch from fully applying, which causes the converter clutch to slip.

To avoid this problem, always check for wear between the stator support bushings and turbine shaft, whenever you're rebuilding one of these transmissions. If you find more than 0.0015" clearance, replace the bushings. These bushings are made by Omega Machine & Tool, Inc. and are available from a number of sources in the aftermarket.

Once you've replaced the bushings, slide the stator shaft into place and recheck the clearance between the shaft and the bushings; while not particularly common, it is possible for the shaft itself to wear and need replacement.

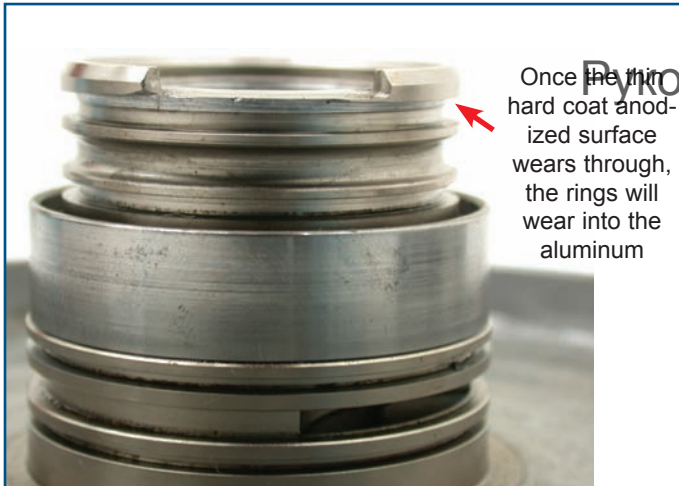
Figure 3

Once the thin hard coat anodized surface wears through, the rings will wear into the aluminum

It's not uncommon to see wear in the end cover, around the top direct

clutch ring land area (figure 3). On Mazda applications, the end cover is aluminum and is hard coat anodized around the ring land area (figure 4). This hard coating is designed to prevent the rings from wearing into the soft aluminum. Once the thin anodized coating wears through, the ring wears into the bare aluminum, destroying the cover.

So, to avoid wear in the end cover, you should always use the Ford cover. Whenever you rebuild an FN4A-

EL/4F27E transmission, check the end cover carefully to see which one is being used. Never reuse the hard coat anodized cover, even if there's no sign of wear in the ring area. Always replace the Mazda-style end cover with a Ford cover, part# XS4Z-7222-BA. This cover will work on all models, with a few minor modifications:

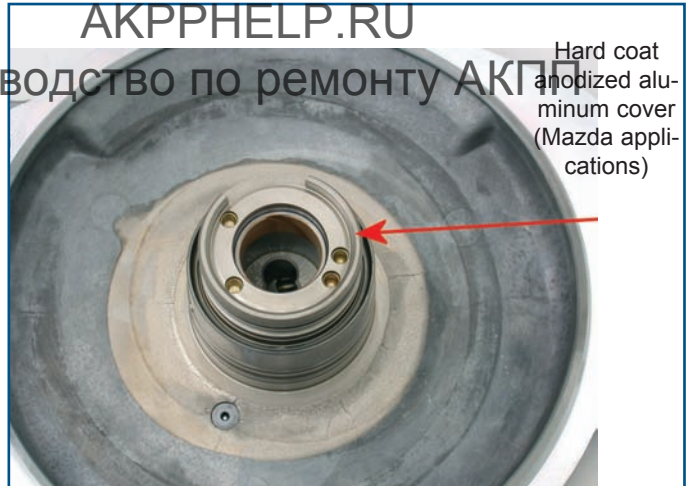
Figure 4

Hard coat anodized aluminum cover (Mazda applications)

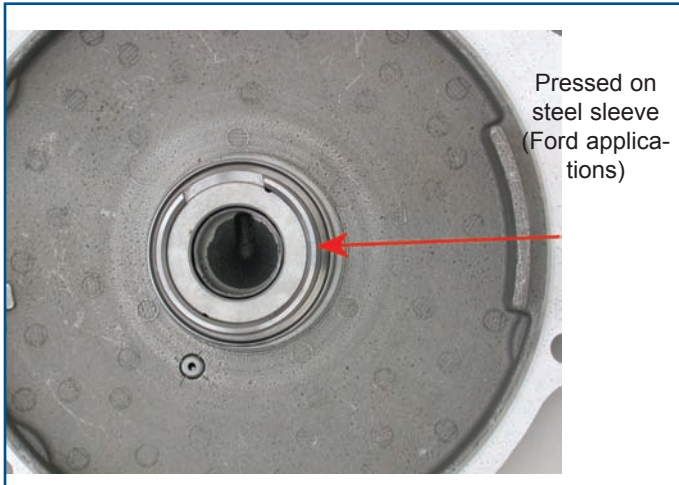
Figure 5

Pressed on steel sleeve (Ford applications)

The end cover used in Ford applications is also made out of aluminum, but this cover has a pressed steel sleeve for the ring land area (figure 5). And, since the direct clutch rings ride against the steel surface, ring land wear isn't a problem on Fords.

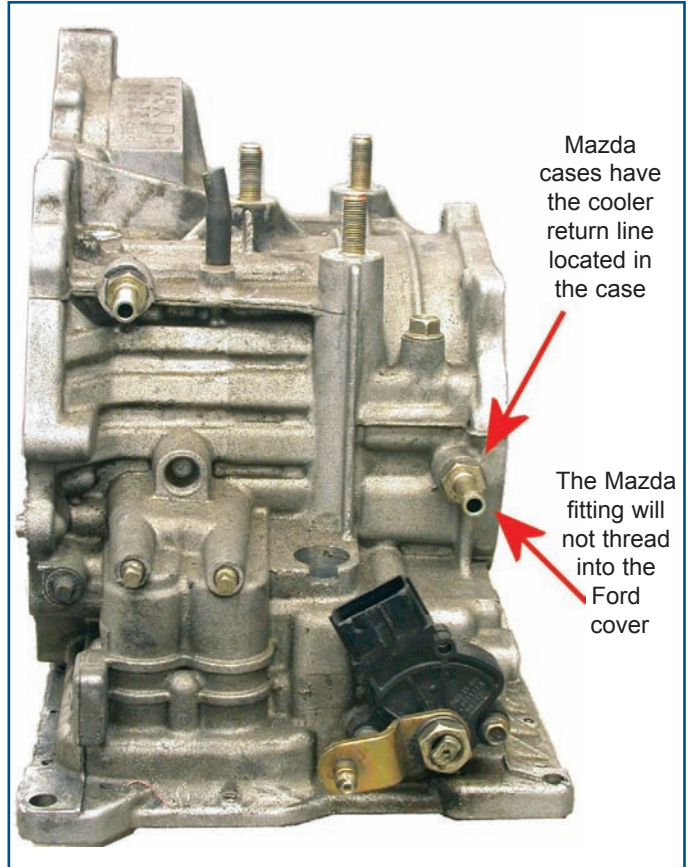
Figure 6

Mazda cases have the cooler return line located in the case

The Mazda fitting will not thread into the Ford cover

The Mazda version of the FN4A-EL/4F27E transmission has the cooler return line located in the case (figure 6). From there it's routed through a passage to the end cover to provide

To adapt the Ford cover for use with a Mazda transmission, you must reroute the cooler return circuit.

Remove the original cooler line fitting from the Mazda case to use it as a template to make a new fitting. The threads are different and won't fit the Ford end cover. When you order the Ford end cover, also order a 3/8" fitting adaptor from Ford, part# YS4Z-7D273-AA. Install it into the Ford end cover.

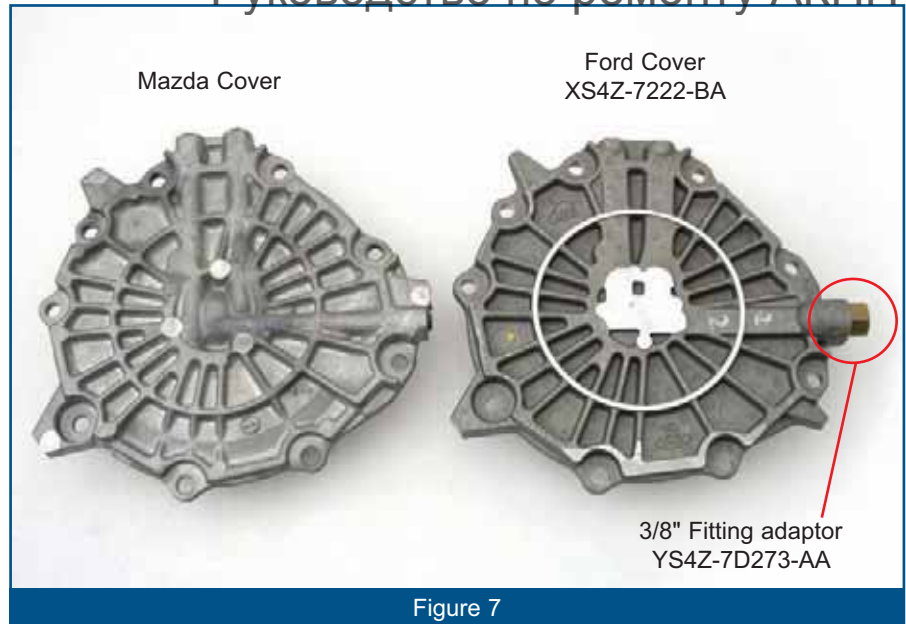
lube oil to the transmission. The Ford version of this transmission has the cooler return line threaded directly into the end cover. Because of this, the Ford end cover doesn't have the cooler return passage from the case that the Mazda cover has (figure 7 and 8).

To adapt the Ford cover for use with a Mazda transmission, you must reroute the cooler return circuit. Here's how:

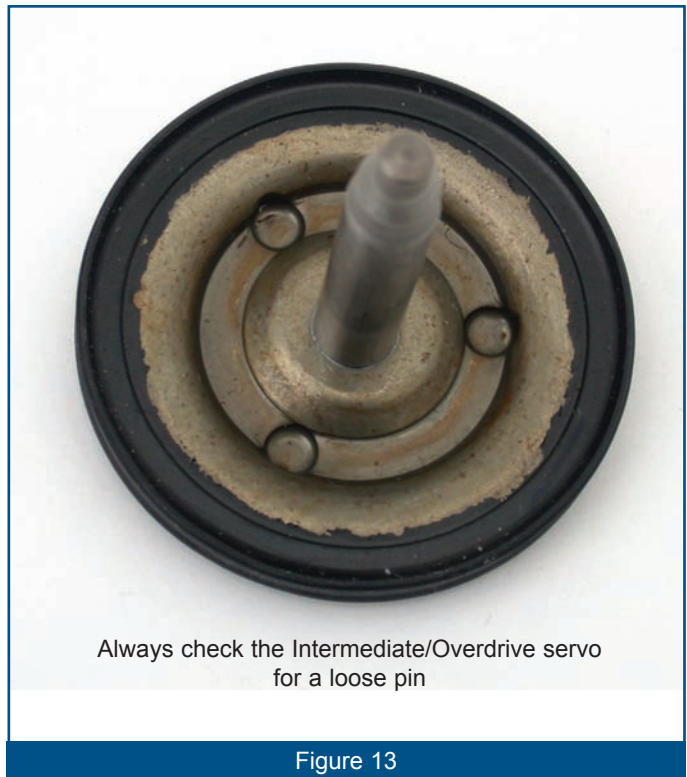
The intermediate/overdrive band servo is a molded rubber piston with a pressed-in pin (figure 13). Problems occur when the pin becomes loose in the piston and causes leaks between the apply side and the release side of the servo. Symptoms of a loose pin can include:

- Ratio errors
- 2nd gear slip
- 2-3 flare
- 3rd gear slip

But the most common symptoms caused by a loose servo pin are a slip in 4th gear and 4th gear ratio codes. If the pin gets loose enough, it will come completely out of the piston, causing major problems (figure 14). To avoid problems from this servo, always replace the servo with a new one during every rebuild.
