AXOD/AXODE (AX4S) UPDATE HANDBOOK

Since the introduction of the Ford AXOD transaxle in model year 1986, there have been many major engineering design changes that have affected many of the parts used in the AXOD transaxle. This version of the AXOD "Update Handbook" begins with the 1986 model year and will explain each change, the parts affected by the change, and any parts interchange problems created by the change. This booklet is an updated version of the original.

This updated version of the AXOD "Update Handbook" will also cover the changes that occurred in the 1991 model year, when electronic controls were adapted to the AXOD transaxle, making it an AXODE, and now called an AX4S transaxle. We have included the changes on the AX4S transaxle up through and including model year 2002.

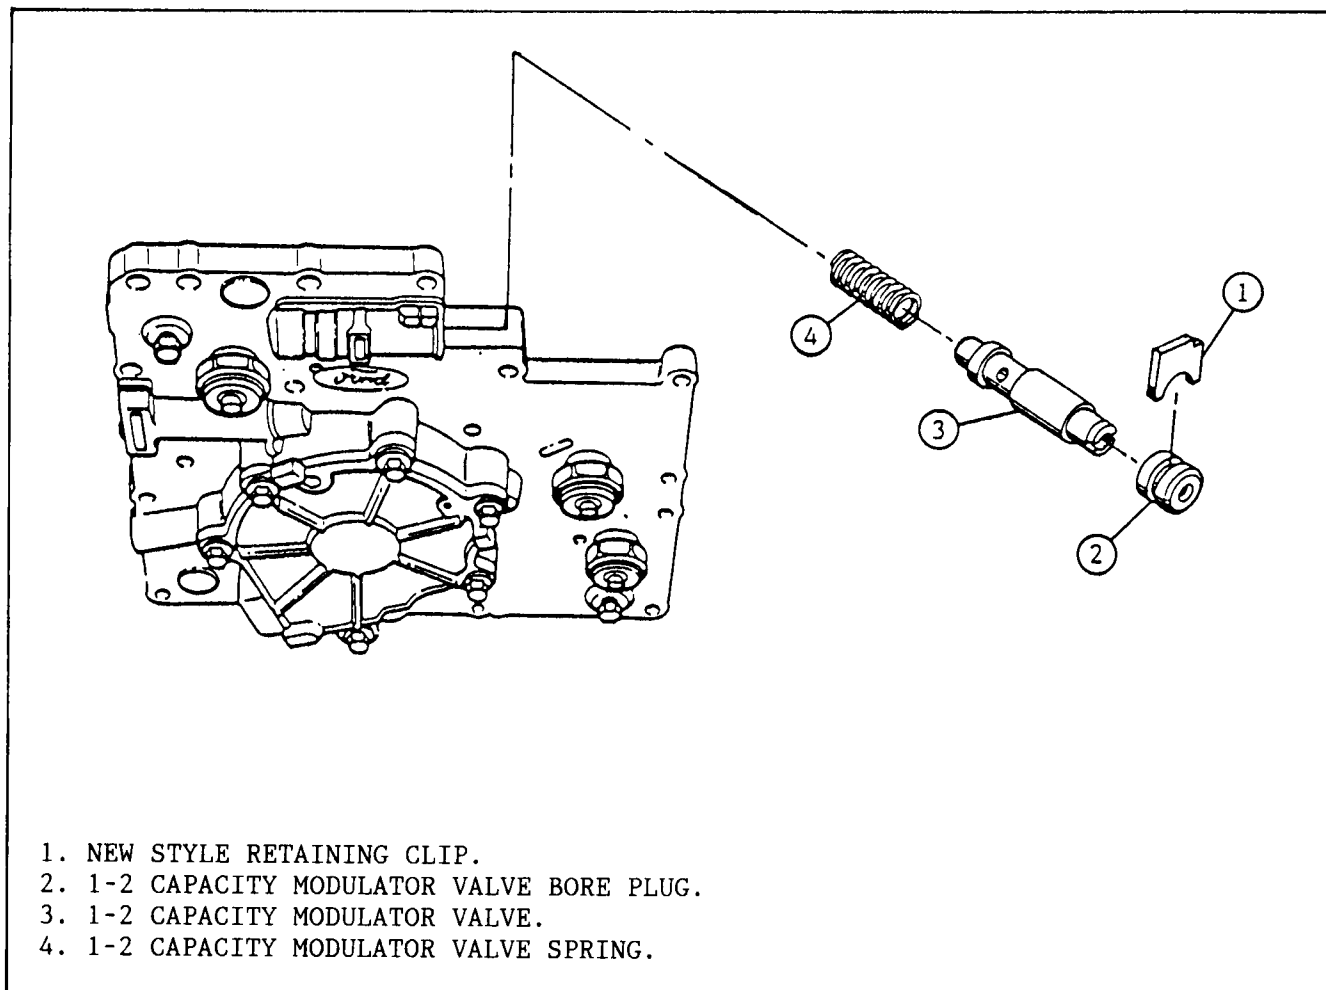
Figure 18

CAUSE: The cause may be a lack of oil volume to the intermediate and/or direct clutch packs.

CORRECTION: FOR SOFT 1-2 SHIFT:
Replace the 1-2 capacity modulator valve spring with the Red spring manufactured by Shift Technology Products (Part #K006). The kit also comes with a new style bore plug retaining clip. Assemble into the oil pump as shown in Figure 18. This modification should be made on all AXOD'S during rebuild.

NOTE: Do not install the valve backwards, as the result will be a one-neutral shift.

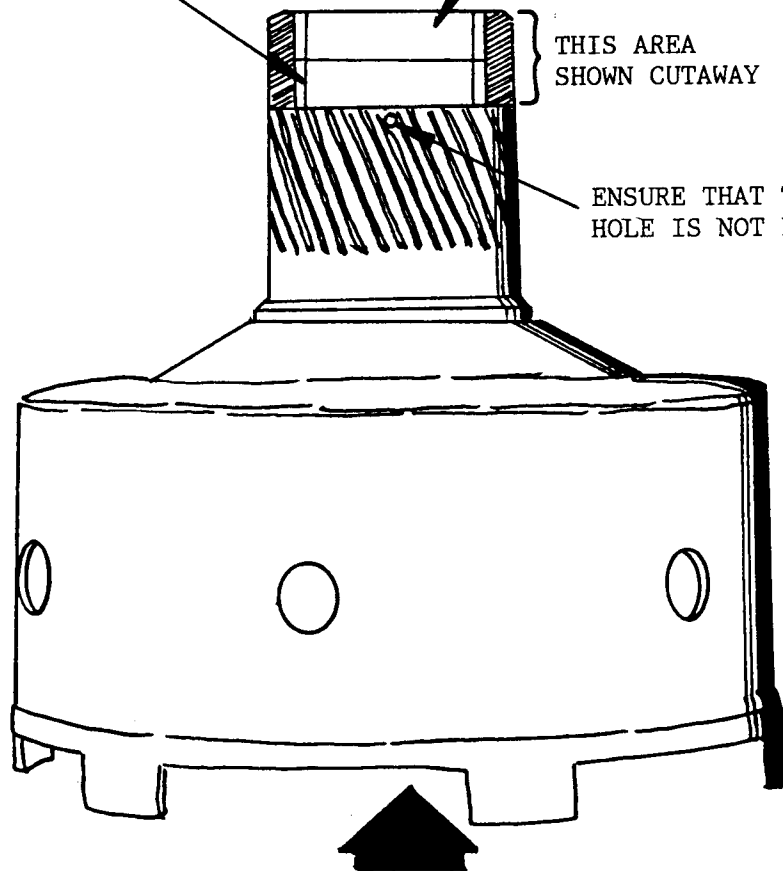
Figure 31

ENSURE THAT THIS LUBE HOLE IS NOT BLOCKED.

3. Inspect the bushings in the rear planetary support, as these bushings can move out of position and block the lube oil hole located in the support between them. The 1988 and later rear planetary support has a new design, wider, one piece bushing with a groove and lube hole in the center. This will provide more surface area to prevent the bushing from moving. Refer to Figure 29.
The later rear planetary support, with the 2nd design bushing, will retro fit back to ALL previous models and is highly recommended. The new design rear planetary support is available under OEM part number E6DZ-7A130-A.

SUPPORT SUN GEAR FROM THIS END WHILE PRESSING BUSHINGS TO PREVENT DAMAGE TO SUN GEAR SHELL.

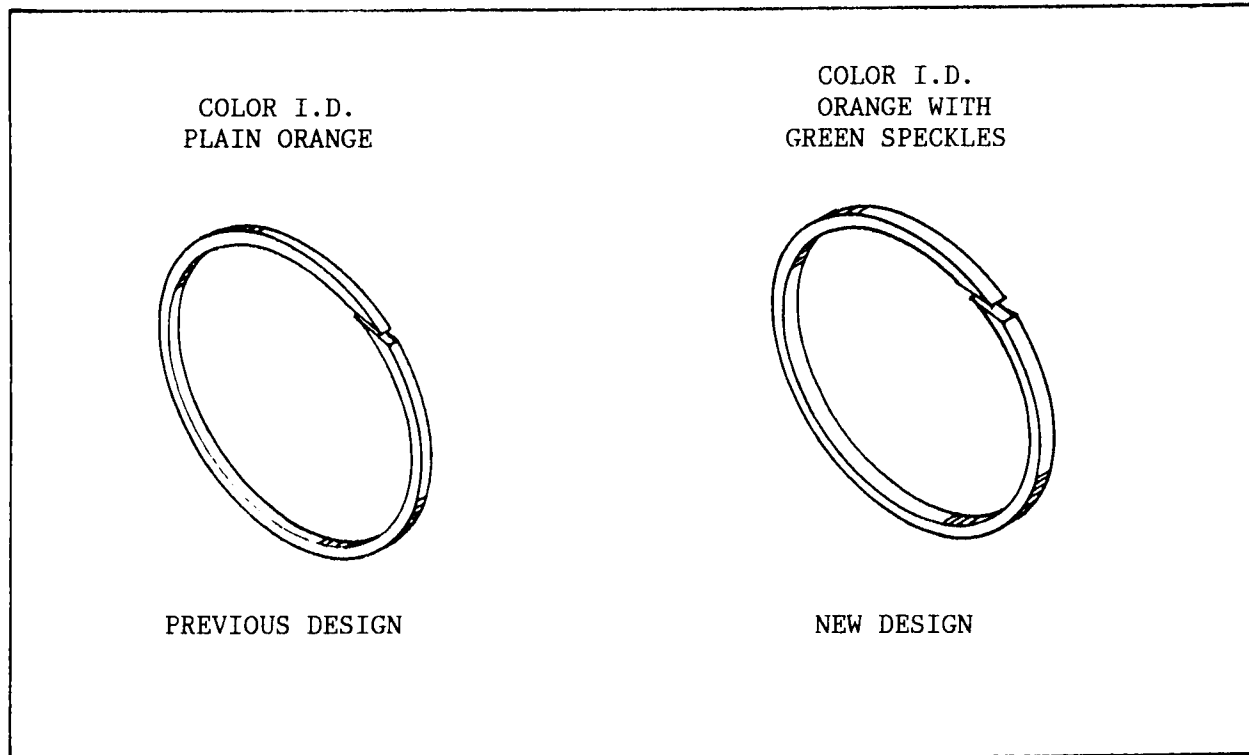
Figure 37

The five sealing rings on the driven sprocket support have been re-designed to help eliminate leakage in this area. The width of the sealing rings has been increased by approximately .015", and the new color identification is orange with green speckles (See Figure 37). The previous design sealing rings were plain orange in color.

The new design sealing rings are available under OEM number E6DZ-7D019-A, and should be used on ALL previous model AXOD transaxles.

DO NOT USE PREVIOUS DESIGN SEALING RINGS.

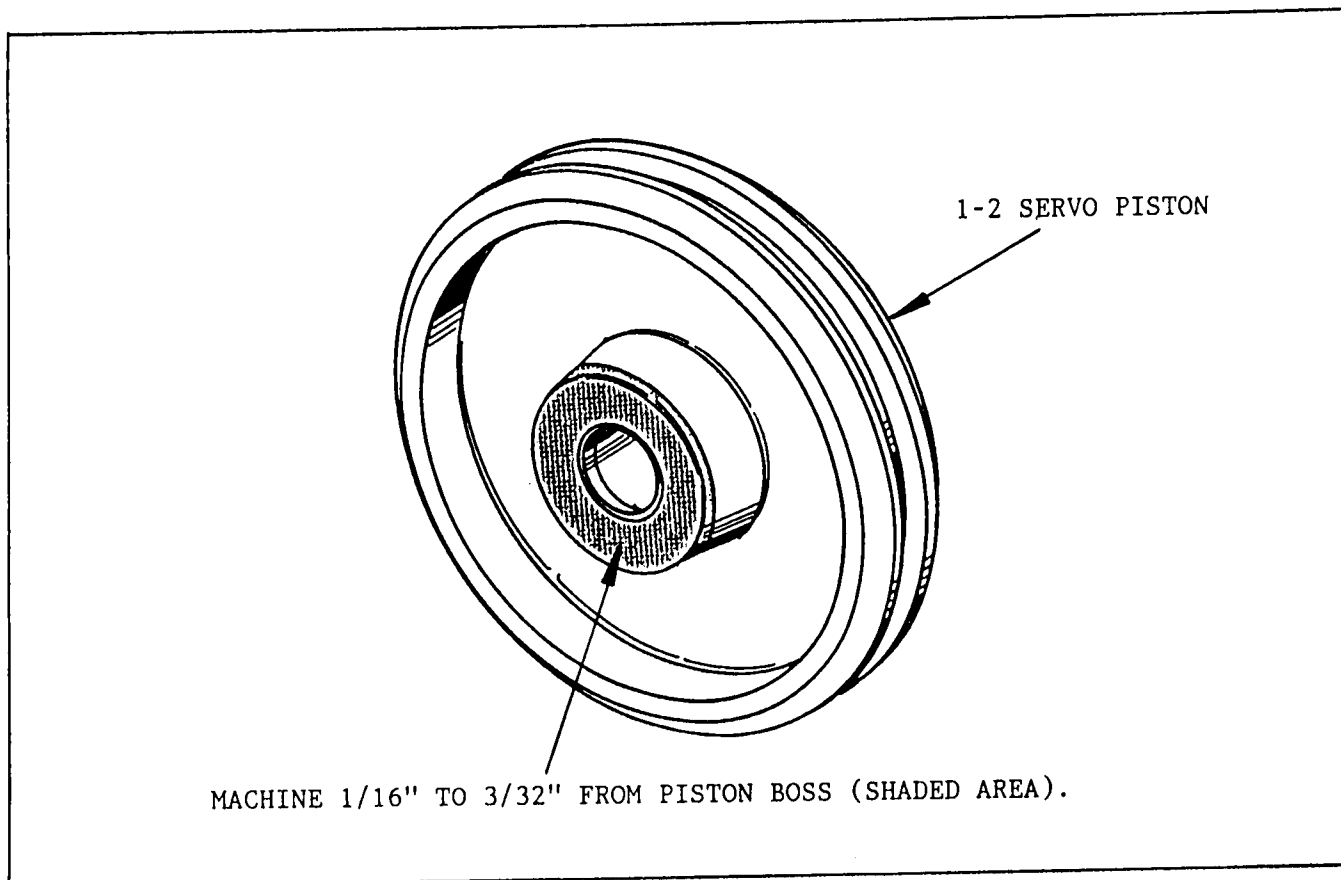
Figure 40

CAUSE: Insufficient travel of the 1-2 piston against the cushion spring.

CORRECTION: Remove 1/16" to 3/32" from the boss on the inside of the 1-2 servo piston as shown in Figure 40. We have shaded the area to be machined (See Figure 40).

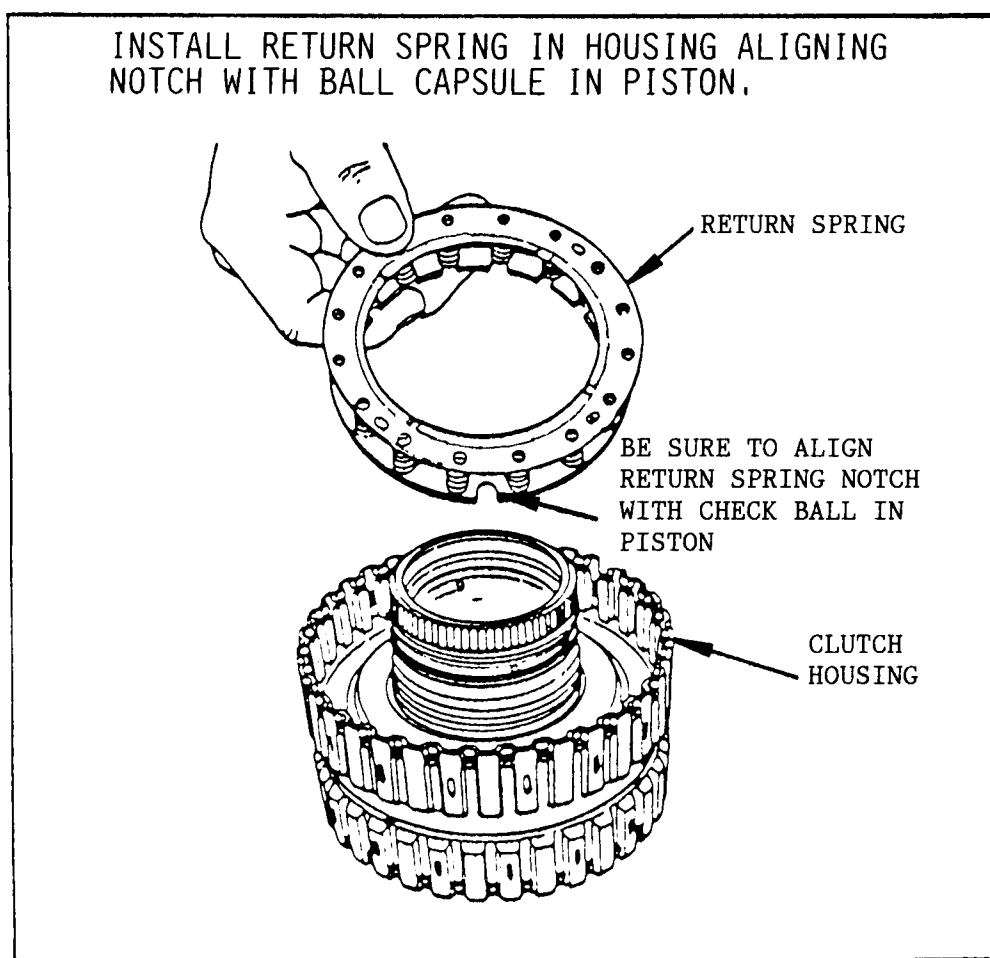
Figure 41

- COMPLAINT:** An extended 3-4 shift with possible direct clutch failure or a NO 3-4 shift condition.
- CAUSE:** This condition may be caused by a partially or fully blocked oil flow of the direct clutch piston check ball assembly.
- CORRECTION:** Special care must be taken during the overhaul operation when re-assembling the direct clutch return spring over the direct clutch piston. Make sure that the notch in the spring bottom retainer (See Figure 41) is positioned properly over the check ball capsule so as not to block or restrict oil flow of the check ball assembly. Refer to Figure 41.

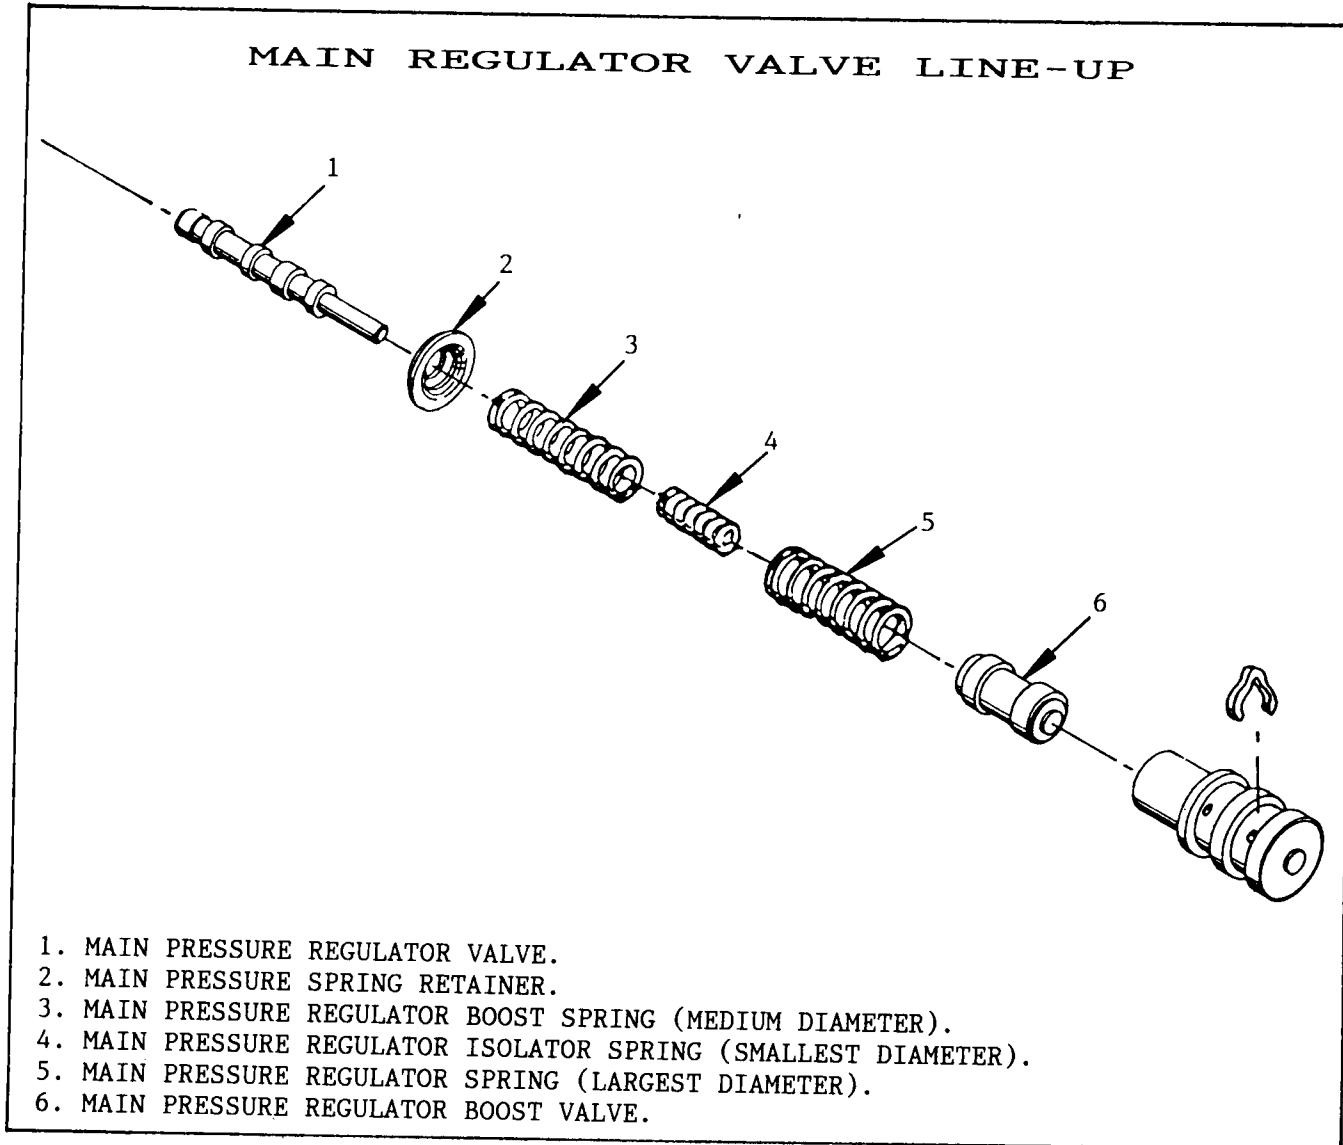
Figure 43

CAUSE: NO. 1. A "Shudder" during a 1-2 upshift will occur if the main pressure regulator "Isolator" spring is not installed after cleaning the valve body (See Figure 43). This is caused by fluctuations in main line pressure at the time of the 1-2 shift.

NO. 2. Delayed upshifts can be caused by the pressure regulator spring retainer being installed backwards (See Figure 43). This will create low main line pressure.

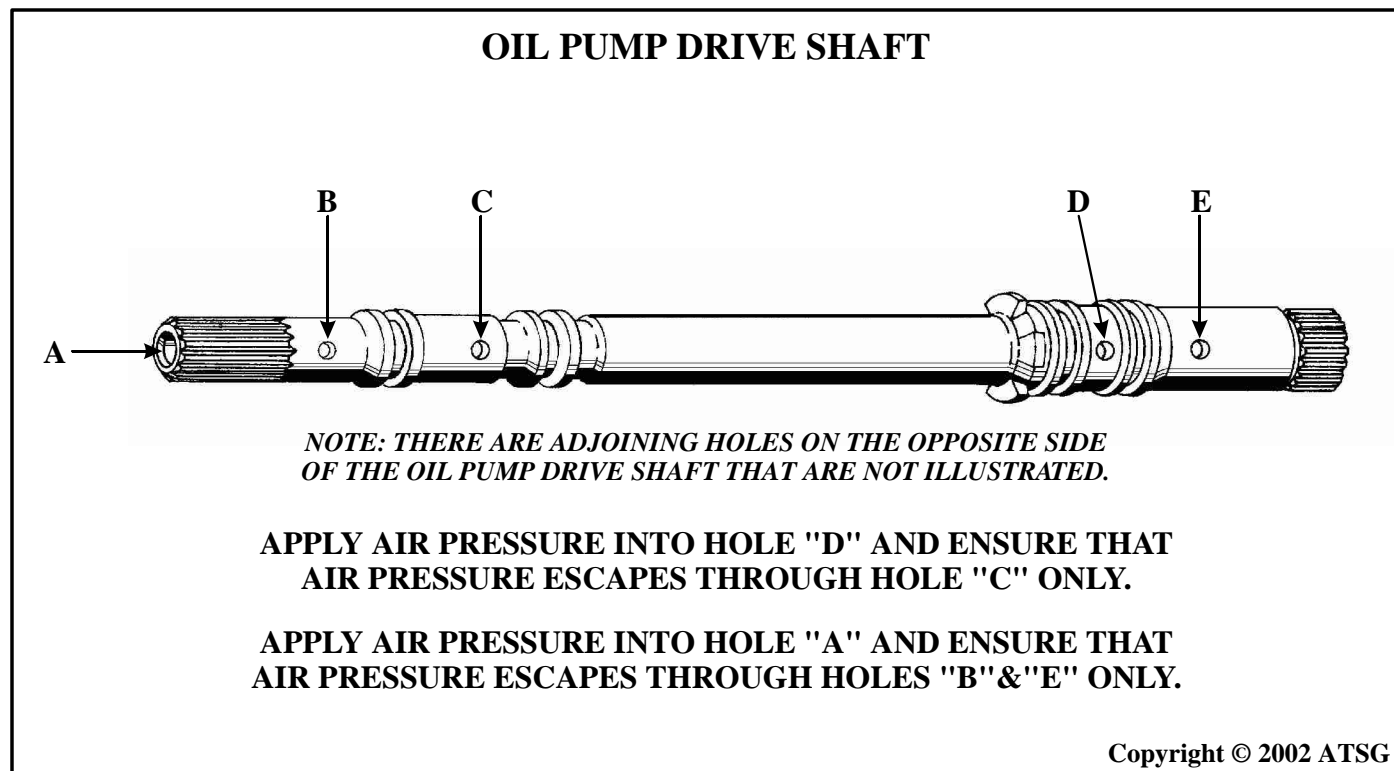
1. *The converter feed passage in the Oil Pump Drive Shaft blocked with debris or was not machined properly to allow converter feed oil to enter the converter.*
2. *The Oil Pump Drive Shaft leaking or not machined properly, allowing converter feed passage and converter release passage to be connected.*

NOTE: *We have seen some replacement shafts, both reman and new that were leaking between the converter apply and release passages.*

CORRECTION: Refer to Figure 64 to *check* the Oil Pump Drive Shaft, and clean or replace as necessary.

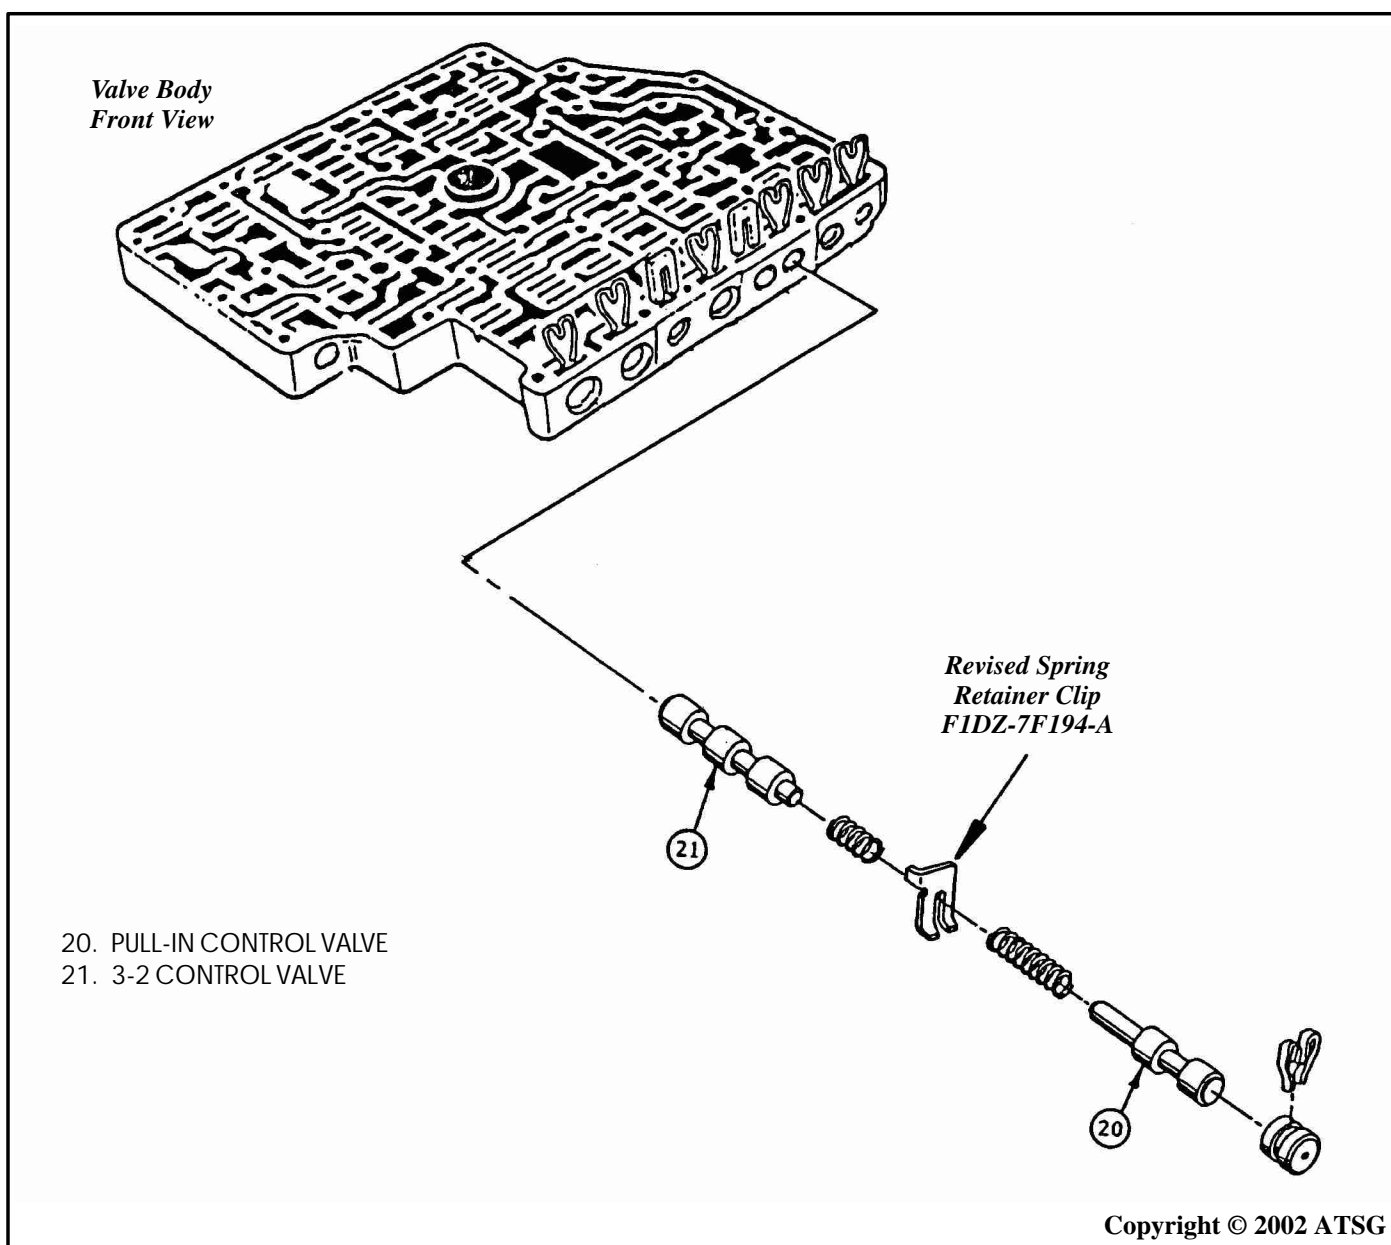
Figure 75

CAUSE: The cause may be, a broken spring retainer clip between the pull-in control valve spring and the 3-2 control valve spring, as shown in Figure 75.

CORRECTION: Replace the spring retainer clip with OEM part number F1DZ-7F194-A, as shown in Figure 75.

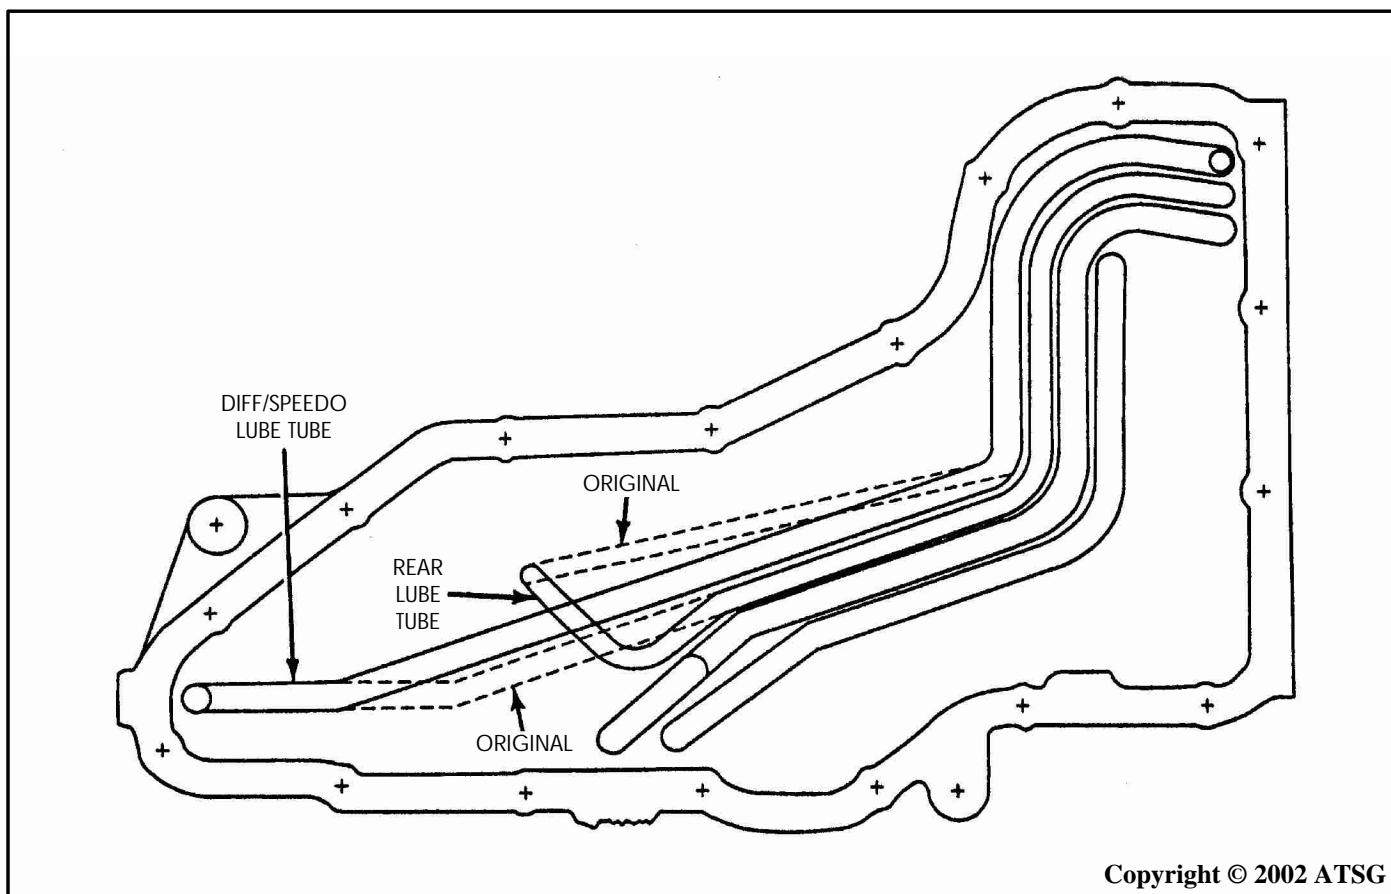
Figure 83

COMPLAINT: Front planetary and gear train failure with no visible root cause.

CAUSE: The cause may be, a limited volume of lube oil to the front planetary due to hydraulic control system demands.

Crossover Rear Lube Tube	F2DZ-7G084-A
Differential/Speedo Lube Tube	F2DZ-7G086-A

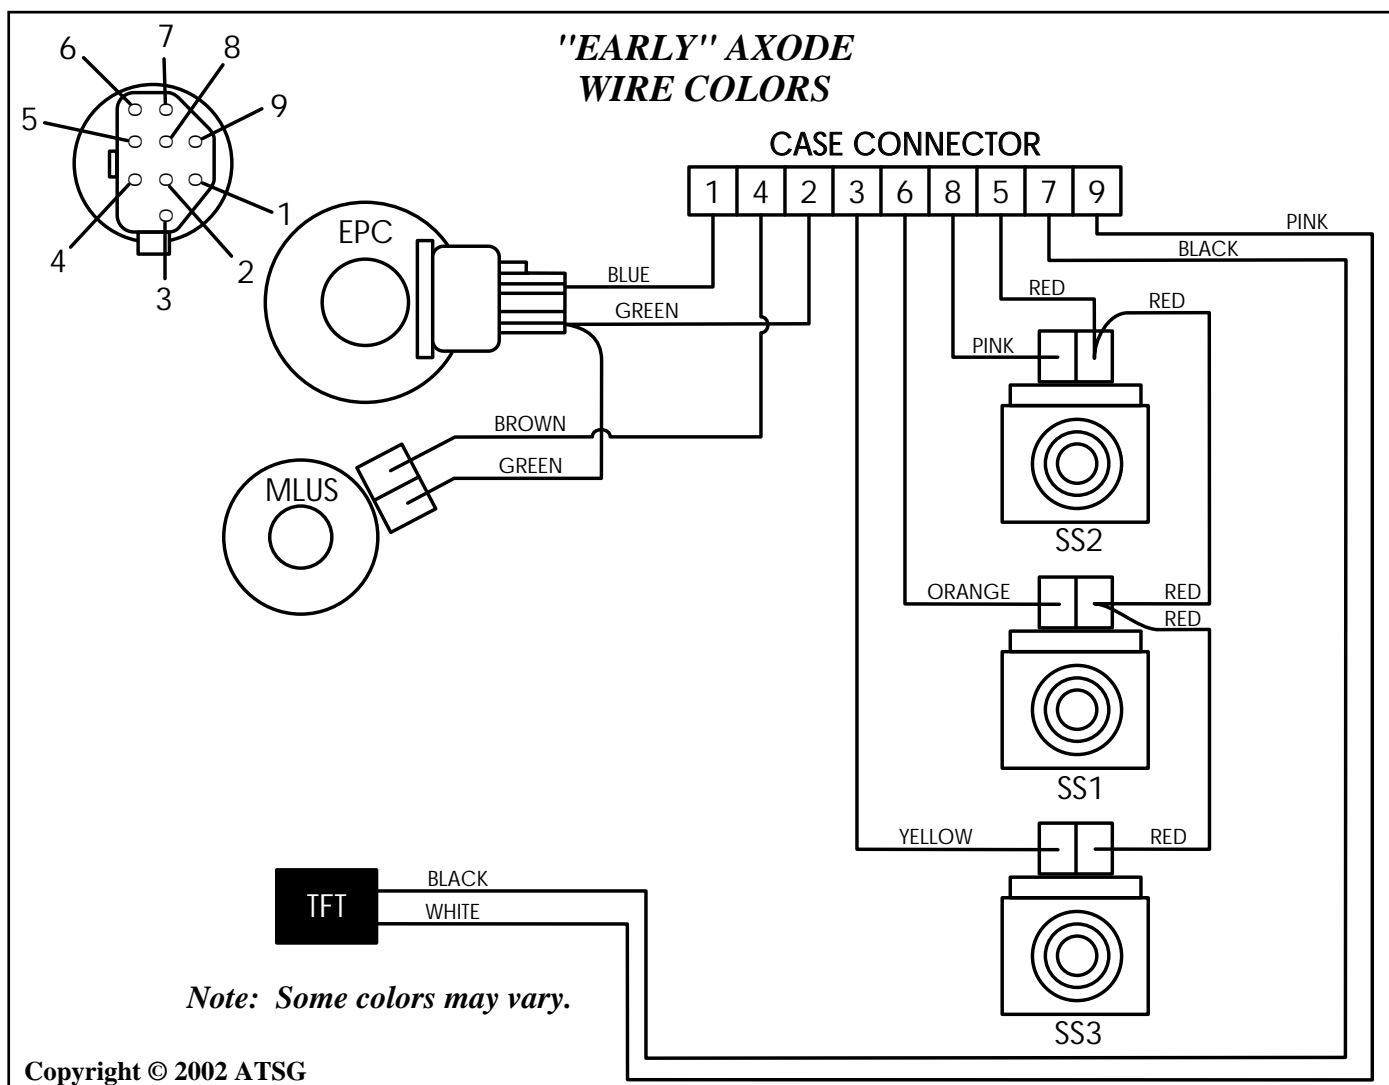
Figure 90

COMPLAINT: *After rebuild*, harsh shifts (High Line) and/or a "Clicking" or cycling noise may be heard from the side cover area, that is usually accompanied by an ON/OFF bind-up sensation that coincides with the "Clicking" noise. These symptoms may be accompanied with Diagnostic Trouble Code (DTC) 652 (MLUS Shorted or Open Circuit), DTC 624 (EPC Circuit Failure), and/or one Shift Solenoid DTC 621, 622, or 624.

CAUSE: The cause may be, solenoid wire connectors installed on the wrong solenoids.

NOTE: The internal wire harness normally is secured by wire-ties which would prevent improper connection of solenoids, however, not all wire harnesses have the wire ties necessary to prevent this problem and the chart must be used.
