AXOD/AXODE (AX4S) UPDATE HANDBOOK

Since the introduction of the Ford AXOD transaxle in model year 1986, there have been many major engineering design changes that have affected many of the parts used in the AXOD transaxle. This version of the AXOD "Update Handbook" begins with the 1986 model year and will explain each change, the parts affected by the change, and any parts interchange problems created by the change. This booklet is an updated version of the original.

This updated version of the AXOD "Update Handbook" will also cover the changes that occurred in the 1991 model year, when electronic controls were adapted to the AXOD transaxle, making it an AXODE, and now called an AX4S transaxle. We have included the changes on the AX4S transaxle up through and including model year 2002.

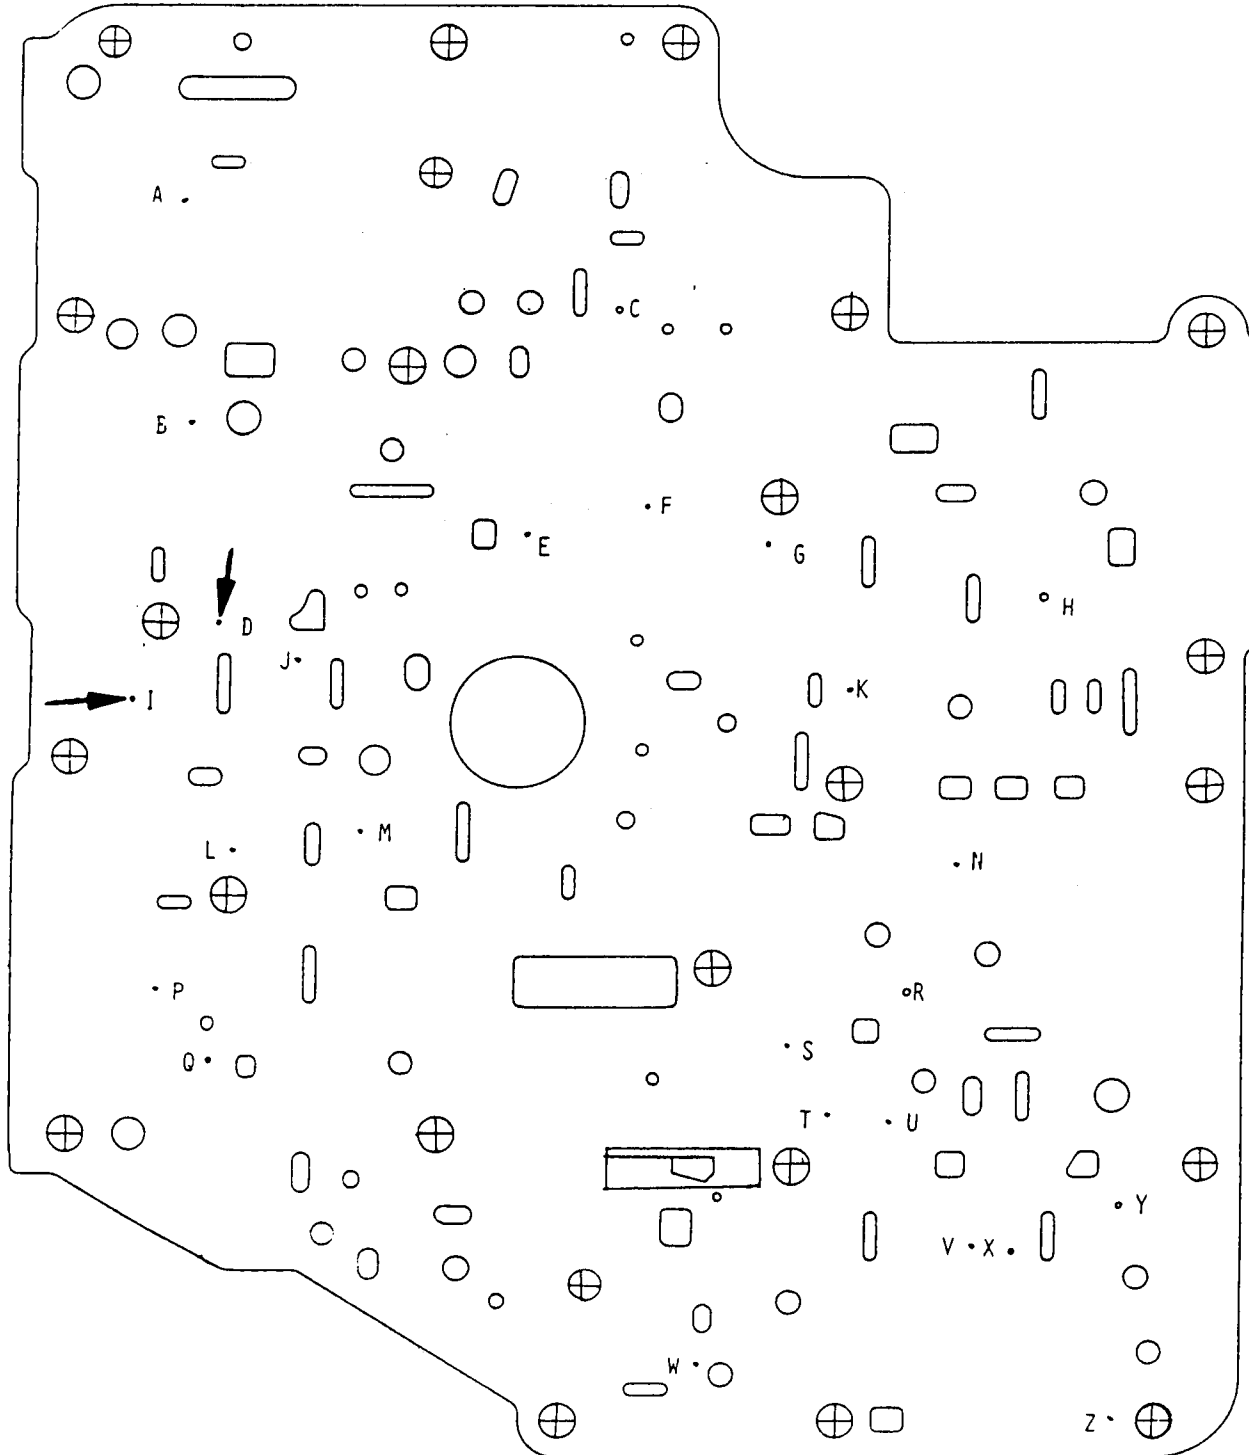
Figure 27

HOLE MARKED "D" - DRILL OUT TO .062" (1/16 INCH).
 HOLE MARKED "I" - DRILL OUT TO .078" (5/64 INCH).

1. Drill the torque converter fill hole in the valve body spacer plate out to .062" (1/16 Inch). This is the hole marked "D" as shown in Figure 27.
Drill the rear lube orifice in the valve body spacer plate out to .078" (5/64 Inch). This is the hole marked "I" as shown in Figure 27.

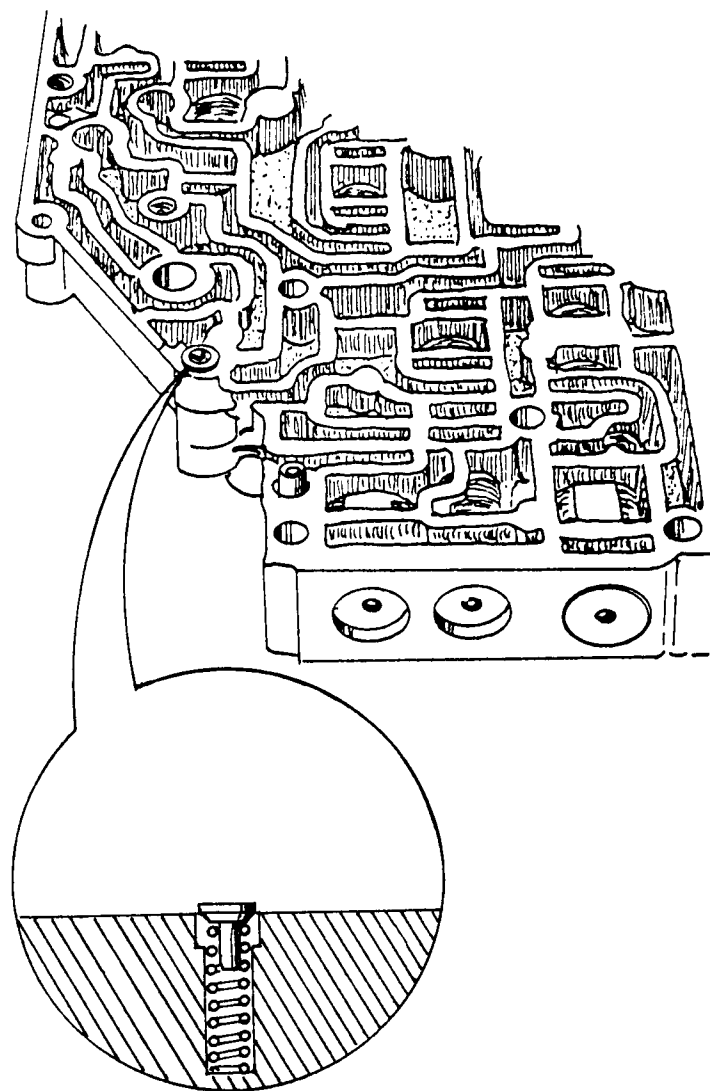
Figure 28

TRIM THE REAR LUBE CHECK VALVE SPRING, UNTIL THE CHECK VALVE SITS ABOUT 1/16" ABOVE THE MACHINED SURFACE OF VALVE BODY.

2. Trim the rear lube check valve spring, which is located in the valve body, until the check valve sits approximately 1/16" above the machined surface of the valve body (See Figure 28). This will require approximately 3 coils be removed from the spring, and always install the cut end of the spring back into the valve body first.

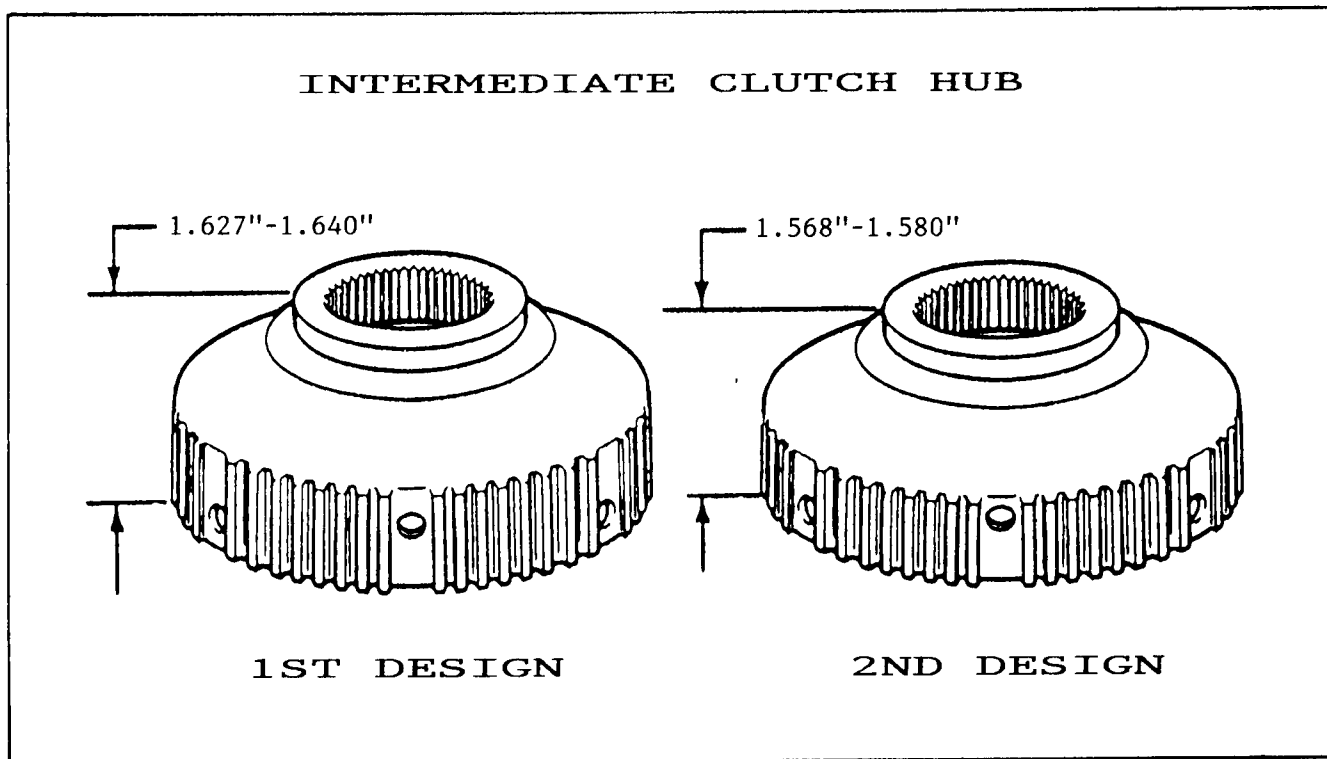
Figure 32

- (2) **INTERMEDIATE CLUTCH HUB** - Overall height was made shorter by approximately .060" with no identifying marks. The hub **MUST** be measured with a dial caliper or depth gage.
The 1st design hub will measure 1.627"-1.640", and the 2nd design hub will measure 1.568"-1.580" as shown in Figure 32.

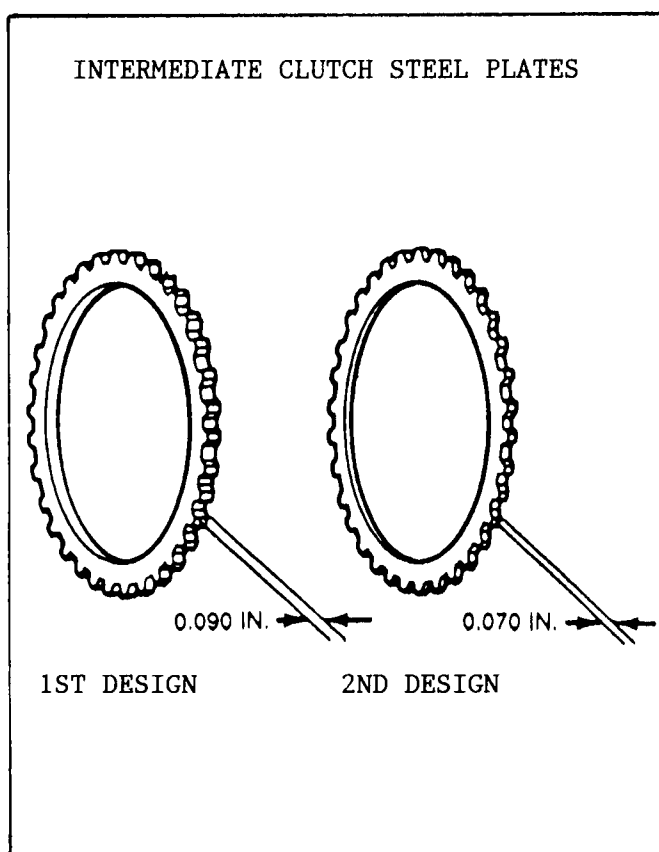
Figure 33

- (3) **INTERMEDIATE CLUTCH STEEL PLATES** - Thickness was reduced by .020" to help accommodate the added wave plate on 3.8L models, or the added spacer plate on 3.0L models.
The 1st design steel plates are .090" thick, and the 2nd design steel plates are .070" thick as shown in Figure 33.

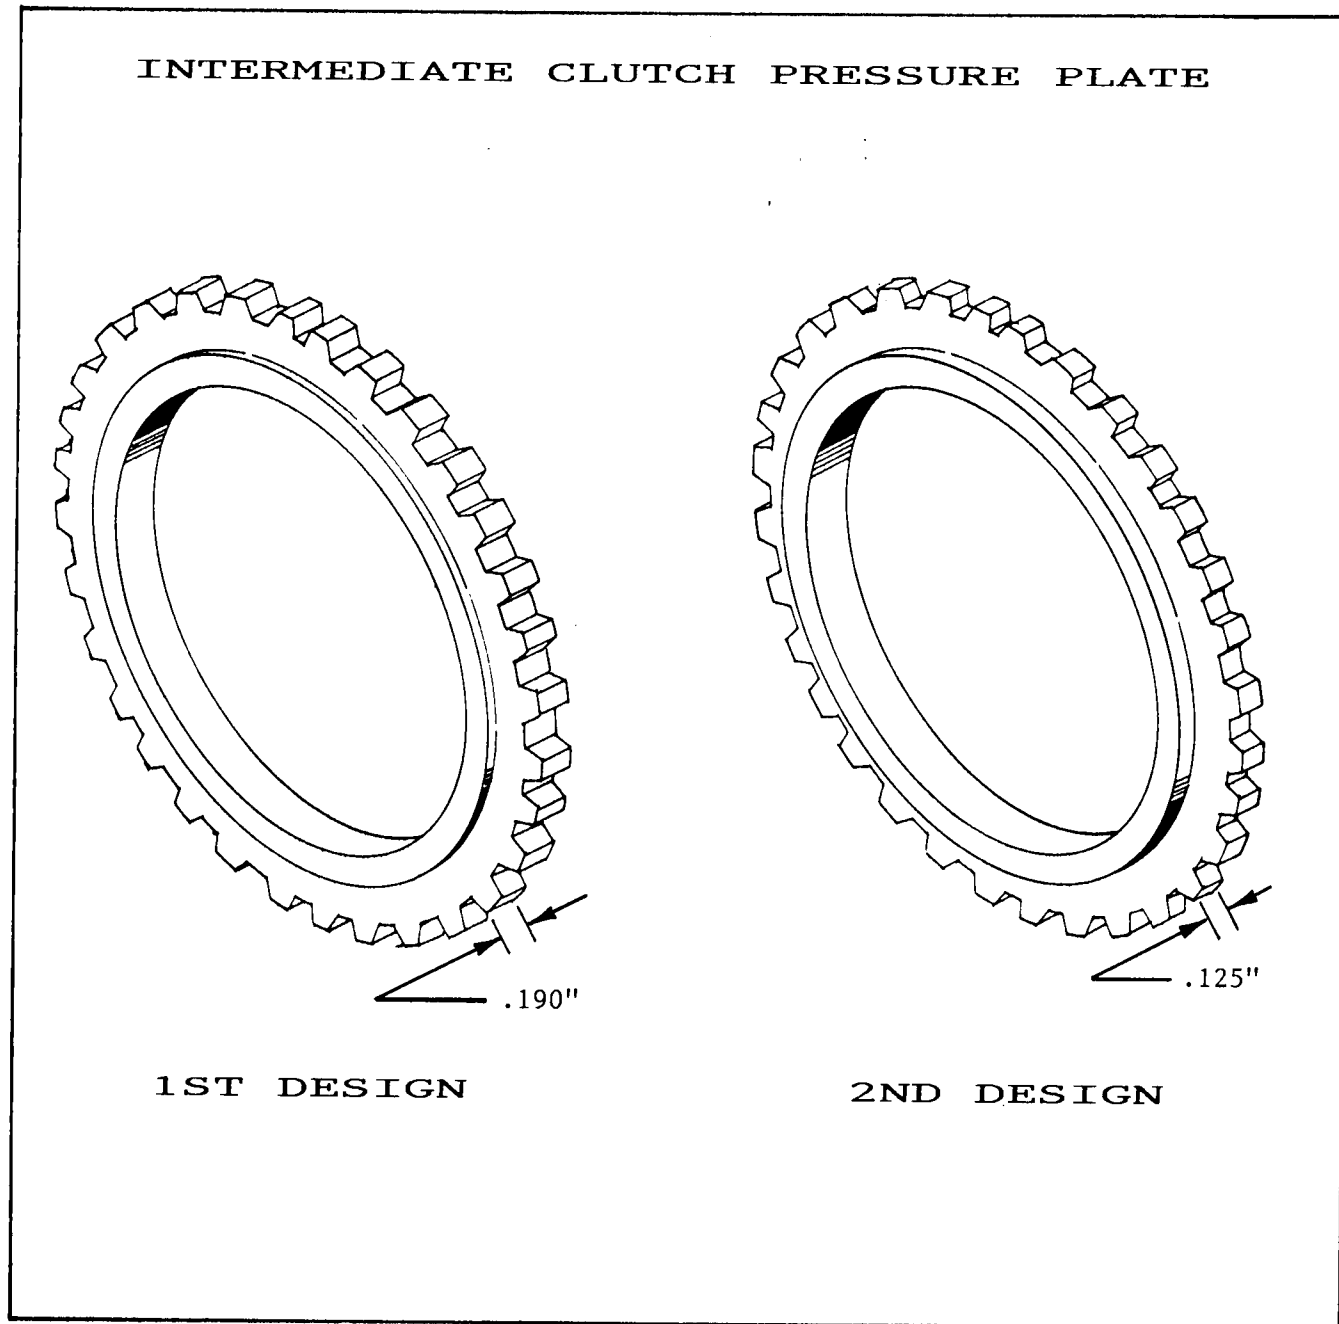
Figure 35

- (4) **INTERMEDIATE CLUTCH PRESSURE PLATE** - Thickness was reduced by .065" to help accommodate the added wave plate on 3.8L models, or the added spacer plate on 3.0L models.
The 1st design pressure plate is .190" thick, and the 2nd design pressure plate is .125" thick as shown in Figure 35.

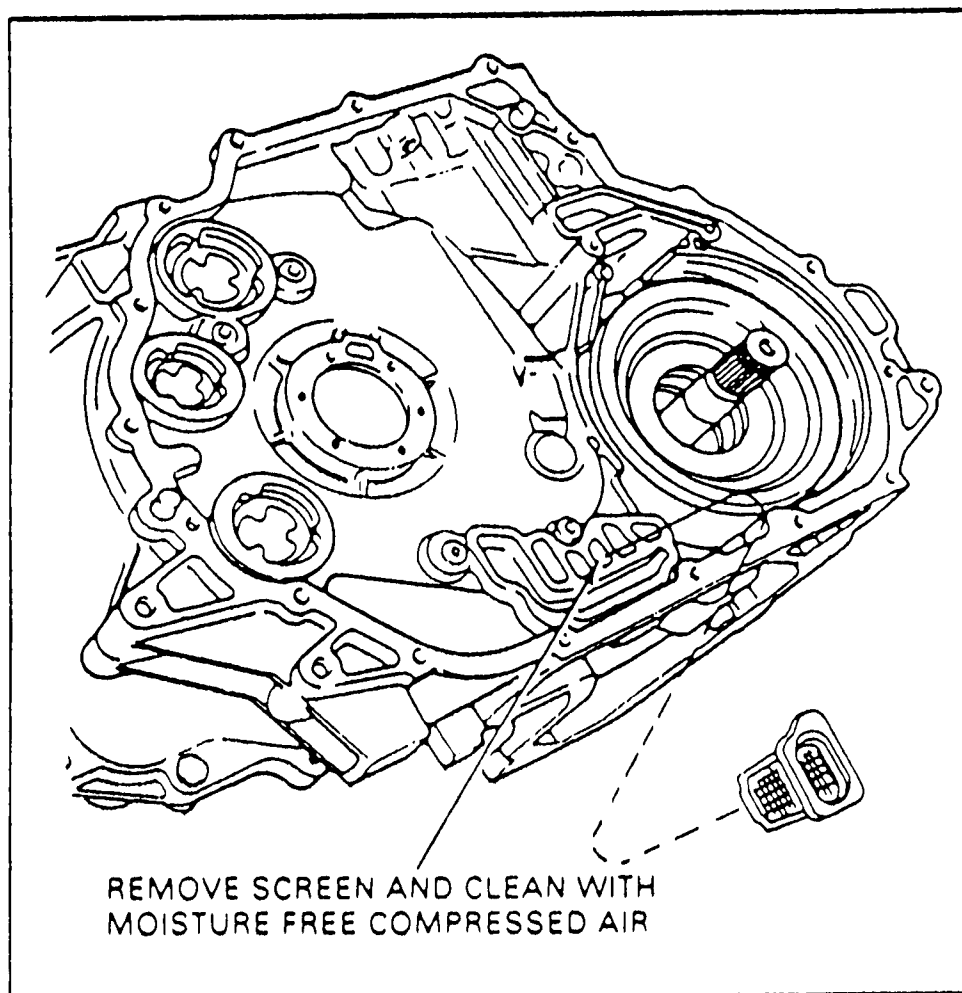
Figure 38

CHANGE: A new filter has been added to the 1989 AXOD 1-2 servo apply circuit as shown in Figure 38.

NOTE: A no forward condition could occur if the filter becomes contaminated.

New Filter E9DZ-7H162-A

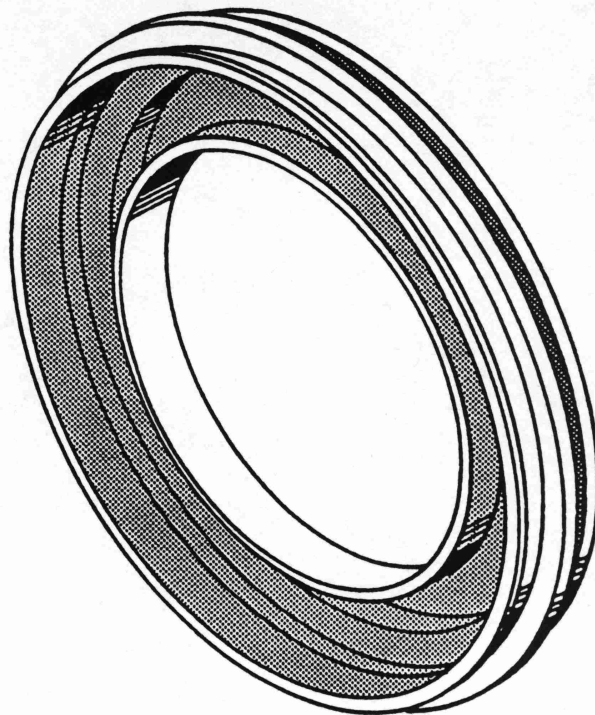
Figure 39

CHANGE: The Forward Clutch Piston material has now been changed to "Steel", instead of the previous design aluminum piston, as shown in Figure 39.

REASON: To eliminate cracks from occurring in the seal groove and greatly improve durability.

- (1) FORWARD CLUTCH PISTON - Now manufactured out of steel, instead of aluminum, and there are no dimensional changes on the piston (See Figure 39).

- Forward Clutch Piston (All Except "SHO" Models) F4DZ-7A262-A
- Forward Clutch Piston (3.2L "SHO" Models Only) F4DZ-7A262-B

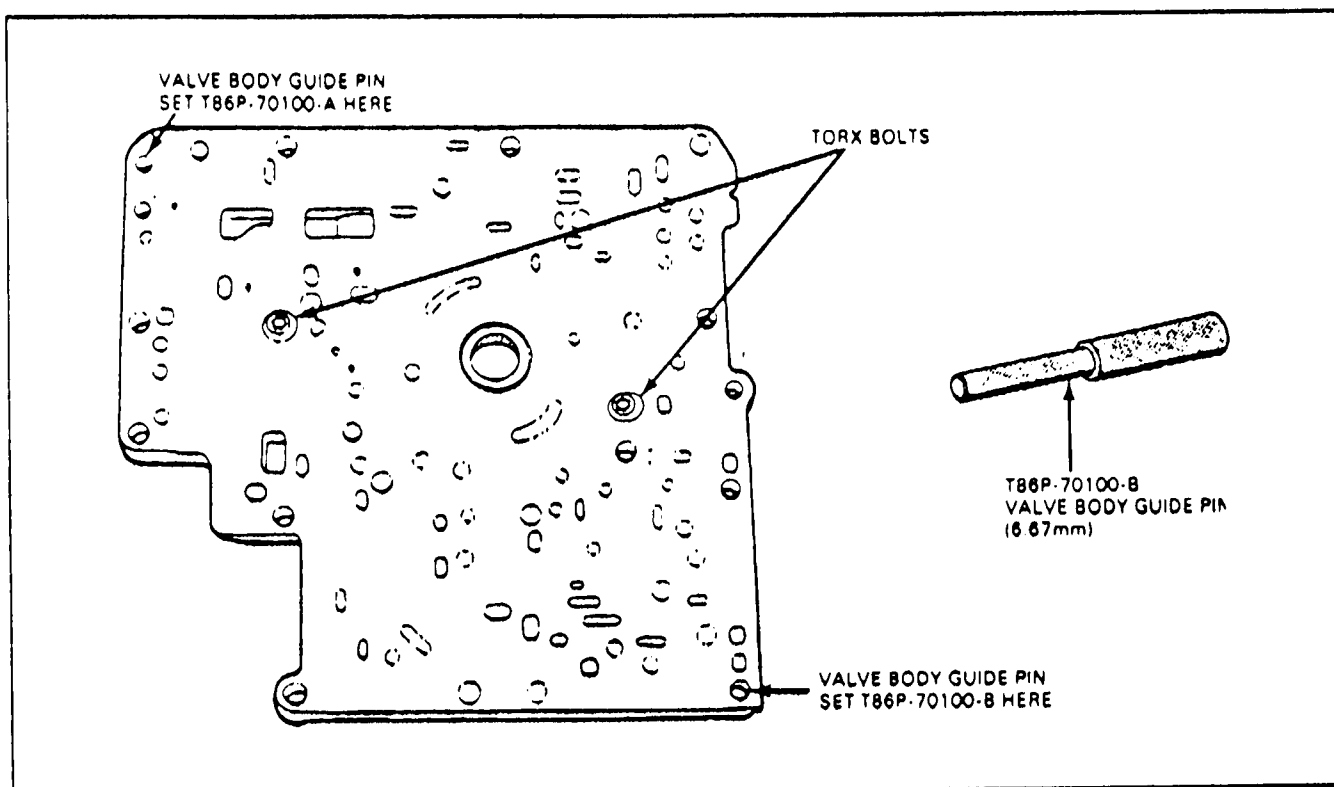
Figure 44

Proper alignment of the oil pump and the valve body are mandatory to prevent premature wear of the oil pump drive shaft and the bearing assembly located in the pump housing. When re-assembling the valve body and oil pump, use the guide pins to assure proper alignment.

1. Position the spacer plate on the pump housing, using a new gasket.
2. Insert valve body guide pin T86P-70100-A (.271" Diameter) and valve body guide pin T86P-70100-B (.262" Diameter), as shown in Figure 44.
3. Install two "Torx" bolts and torque to 7 to 9 ft.lb.
4. Remove both guide pins.
5. Position the spacer plate on the valve body using a new gasket.
6. Insert two valve body guide pins T86P-70100-A (.271" Diameter), as shown in Figure 45.
7. Install two "Torx" bolts and torque to 7 to 9 ft.lb.
8. Position the oil pump on the valve body using a new gasket.
9. Insert pump body guide pin T86P-70370-A and valve body guide pin T86P-70100-C which is .245" in Diameter.
10. Install two valve body to oil pump retaining bolts and torque to 7 to 9 ft.lb.

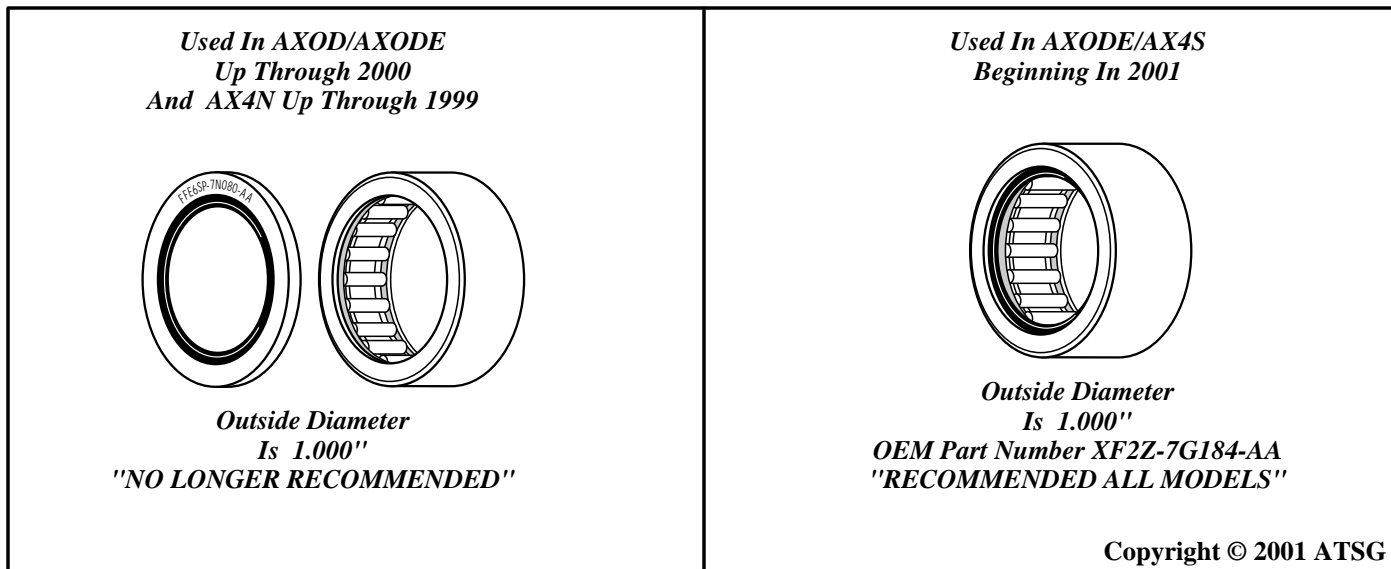
Figure 47

CHANGE: Beginning at the start of production for 2001 on all AX4S transaxles, Ford Motor Company introduced a new design pump bearing that includes an integrated seal, as shown in Figure 47. When this new design bearing and seal assembly went into production, it was installed with the *seal on the valve body side of the pump instead of the rotor side.*

REASON: Greatly reduced pump bearing, pump rotor and vane ring failure, for much improved durability and reliability.

Pump Bearing With Integral Seal XF2Z-7G184-AA

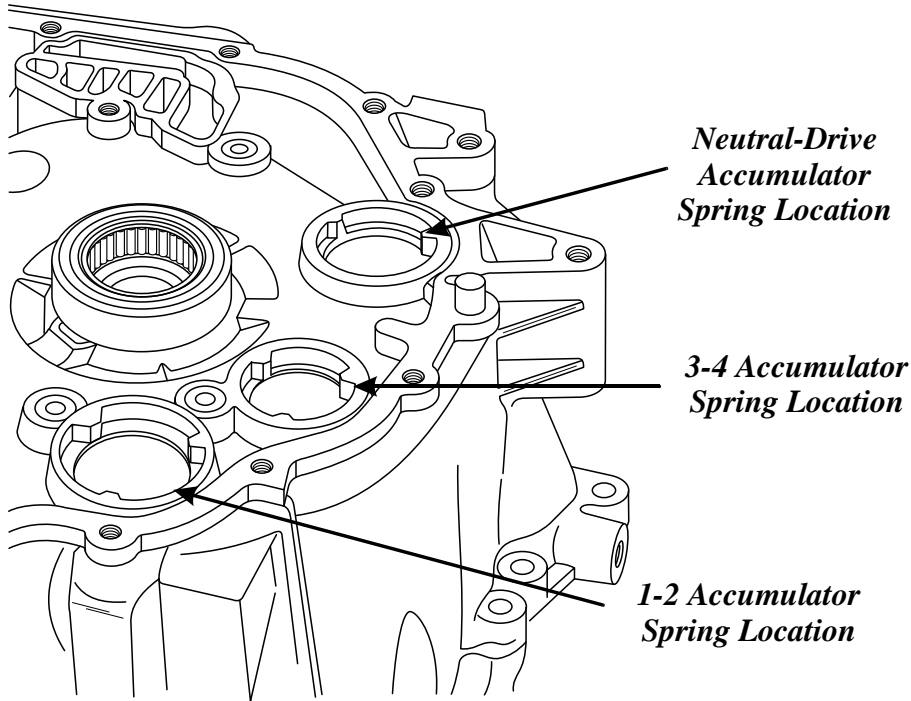
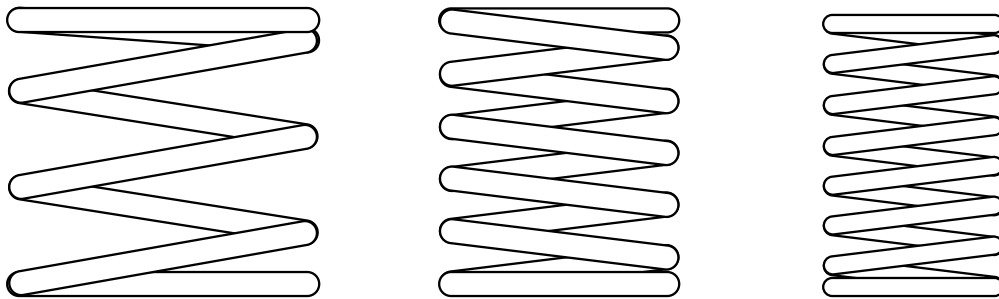
ACCUMULATOR SPRINGS

CAUSE: The accumulator springs may have been installed in incorrect positions, or the accumulator piston shafts are scored or worn and are interfering with proper accumulator piston movement. It is also important to insure that multiple accumulator spring applications must have the springs wound in opposite directions of each other to avoid coil bind, as shown in Figure 49.

SPRINGS ARE WOUND OPPOSITE OF EACH OTHER TO AVOID COIL BIND

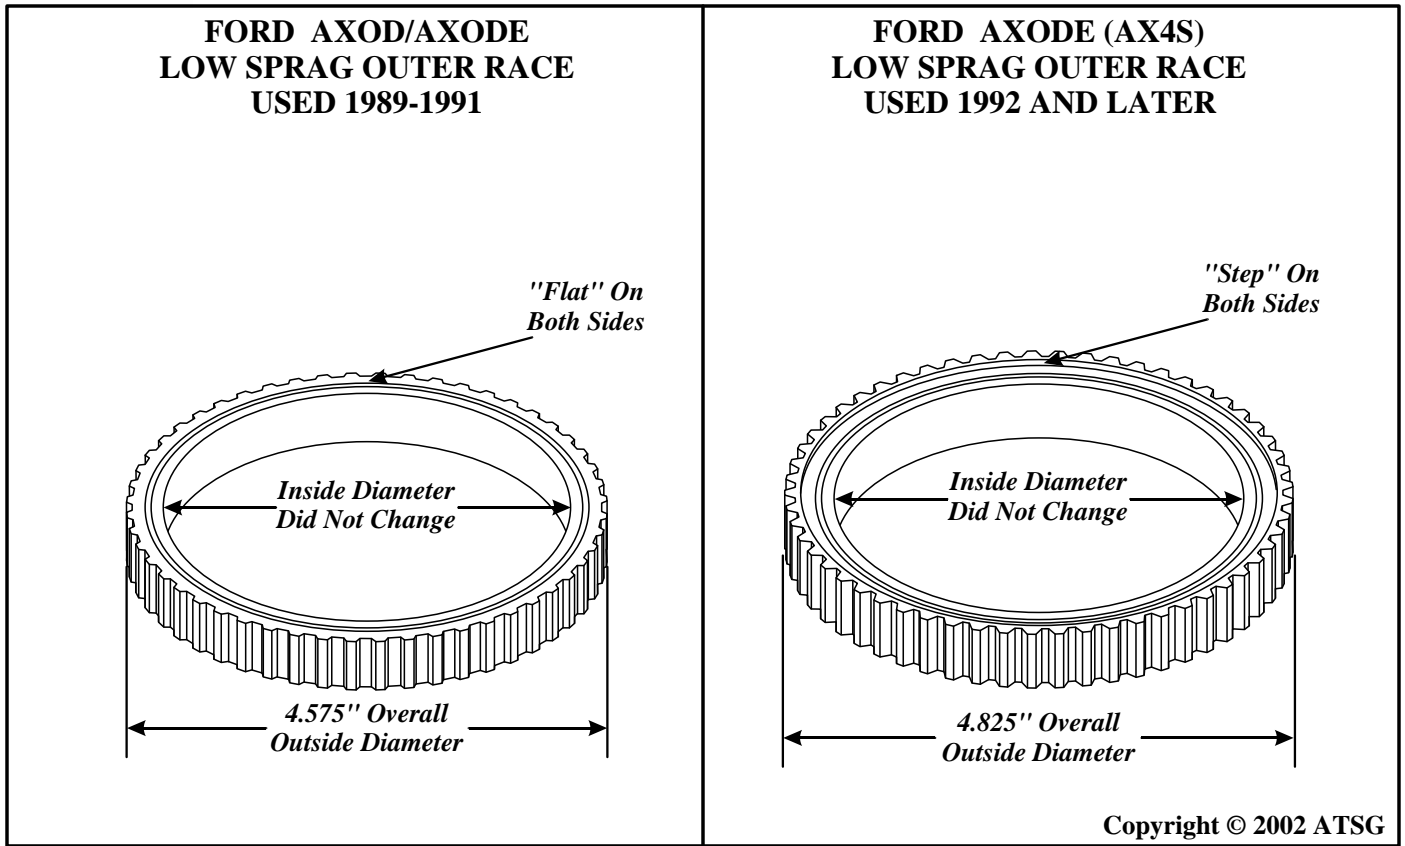
Figure 57

- (1) LOW SPRAG OUTER RACE - The outer diameter of the race was increased from 4.575" to 4.825", and the width of the race was increased from .600" to .725", as shown in Figure 57. *The Inside Diameter of the sprag race Did Not Change.*

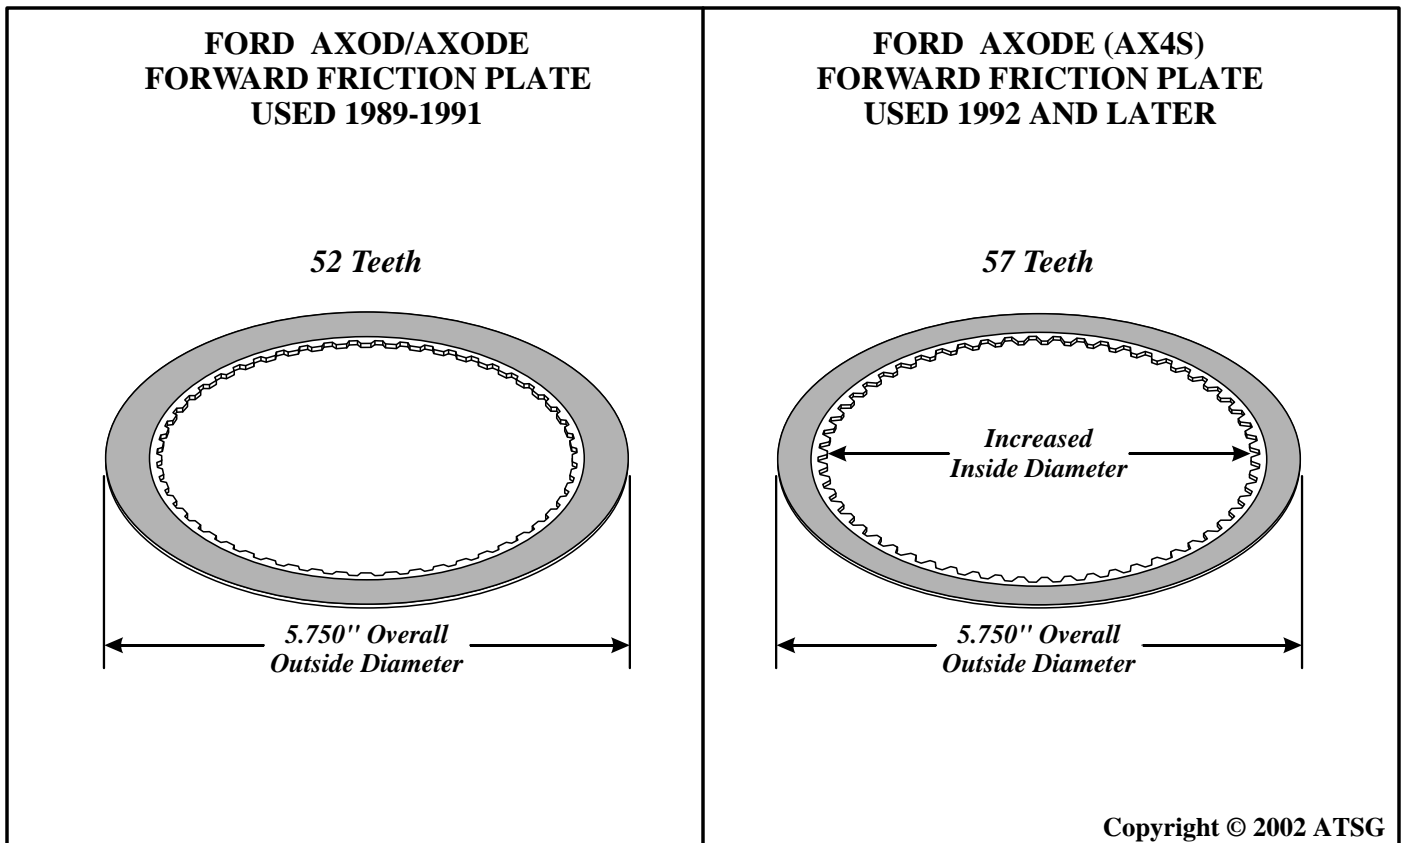
Figure 58

- (2) FORWARD CLUTCH FRICTION PLATES - Have an increased amount of teeth to 57 Teeth from the previous 52 Teeth, to accommodate the increased diameter of the sprag outer race, as shown in Figure 58.

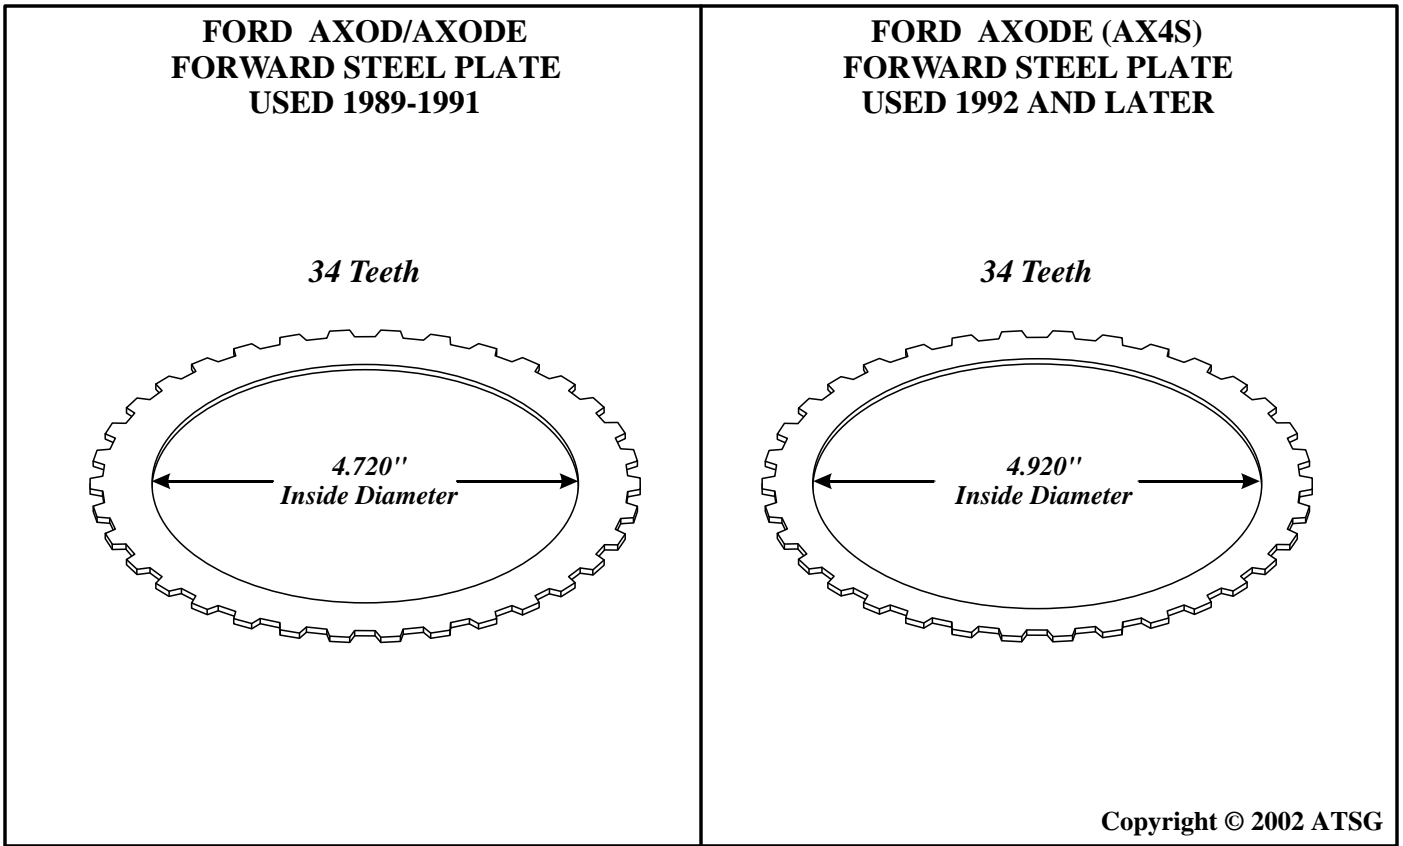
Figure 59

- (3) FORWARD CLUTCH STEEL PLATES - Have an increased inside diameter to 4.920" from the previous 4.720", to accommodate the increased diameter of the sprag outer race, as shown in Figure 59.

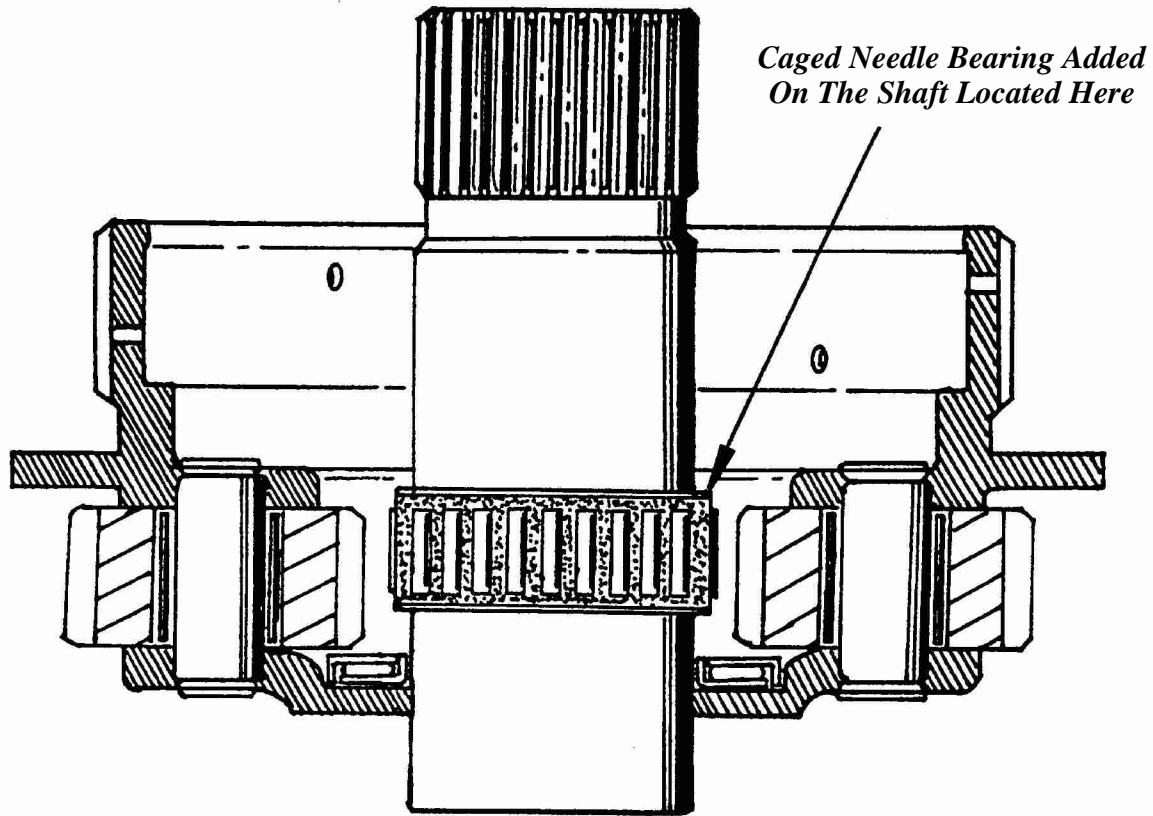
Figure 62

- (1) INPUT PLANETARY CARRIER - New caged needle Bearing added to the shaft on the Input Planetary Carrier, as shown in Figure 62.
- (2) SUN GEAR AND SHELL ASSEMBLY - Single bushing is now located in front of the lube holes in the sun gear, and the area behind is now machined to accommodate the new caged needle bearing, as shown in Figure 63.

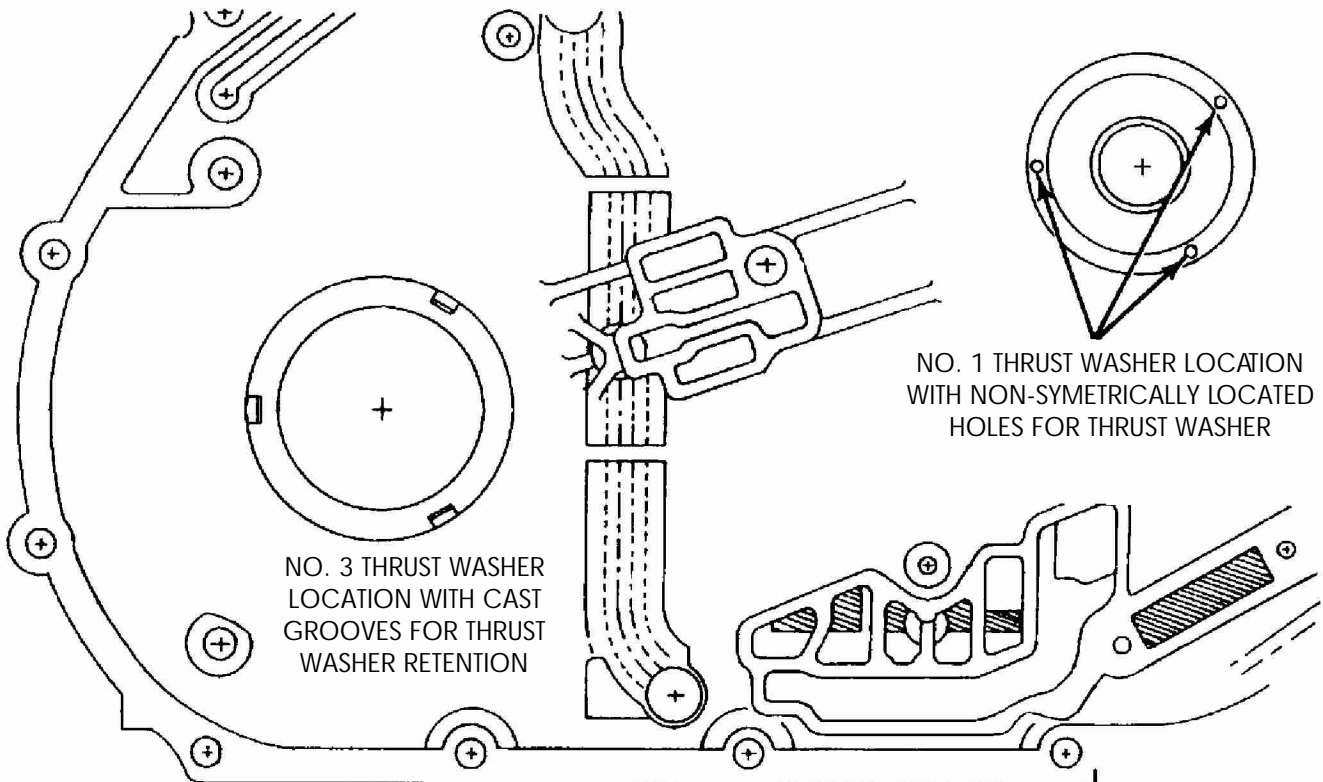
REQUIRES THE PLASTIC NO. 1
THRUST WASHER WITH TABS THAT
ARE NON-SYMETRICALLY LOCATED
PART NUMBER E6DZ-7G099-A

NO. 3 THRUST WASHER
LOCATION WITH CAST
GROOVES FOR THRUST
WASHER RETENTION

NO. 1 THRUST WASHER LOCATION
WITH NON-SYMETRICALLY LOCATED
HOLES FOR THRUST WASHER

If replacement of the number 1 and/or the number 3 thrust washer becomes necessary, inspect the chain cover in the thrust washer tab areas to determine the correct thrust washers required. Refer to Figures 85 and 86.

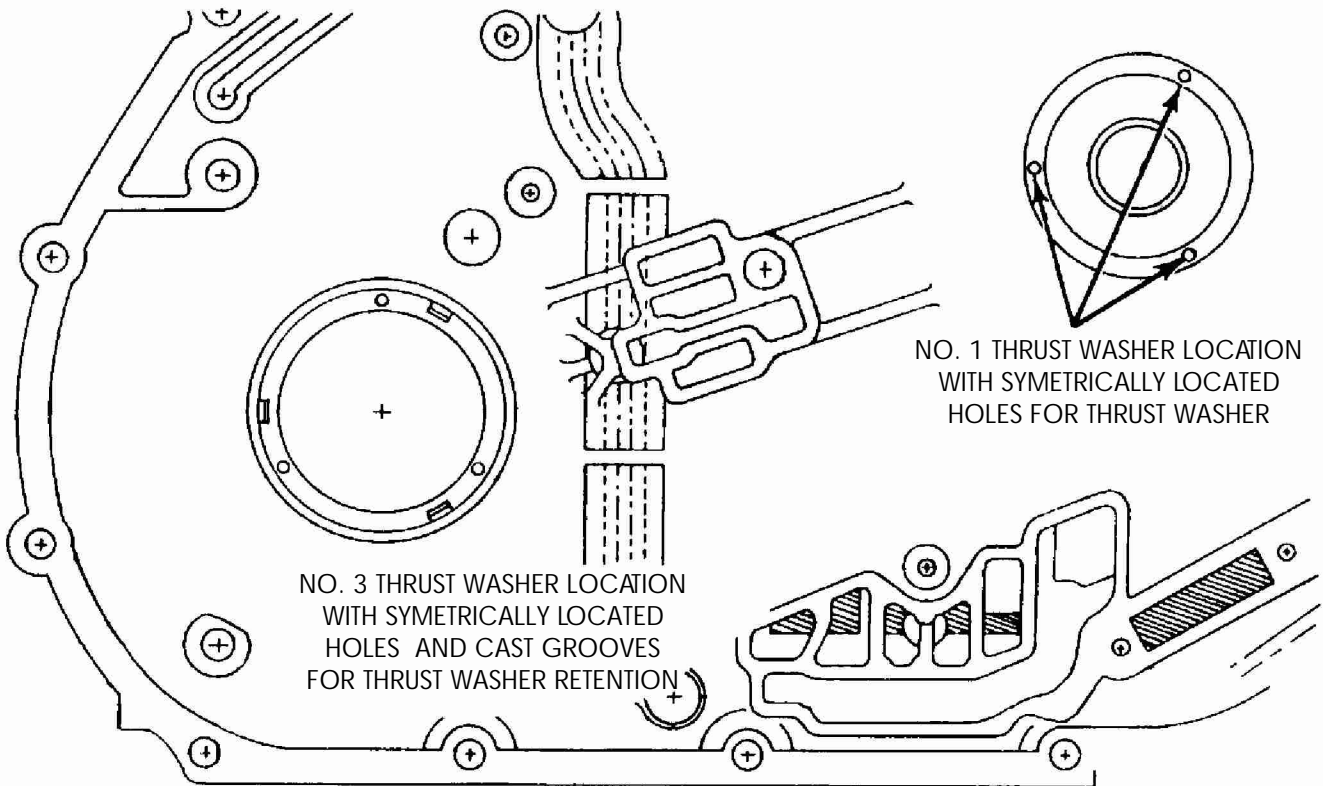
REQUIRES THE PLASTIC NO. 1
THRUST WASHER WITH TABS THAT
ARE SYMETRICALLY LOCATED
PART NUMBER F5DZ-7G099-A

NO. 3 THRUST WASHER LOCATION
WITH SYMETRICALLY LOCATED
HOLES AND CAST GROOVES
FOR THRUST WASHER RETENTION

NO. 1 THRUST WASHER LOCATION
WITH SYMETRICALLY LOCATED
HOLES FOR THRUST WASHER

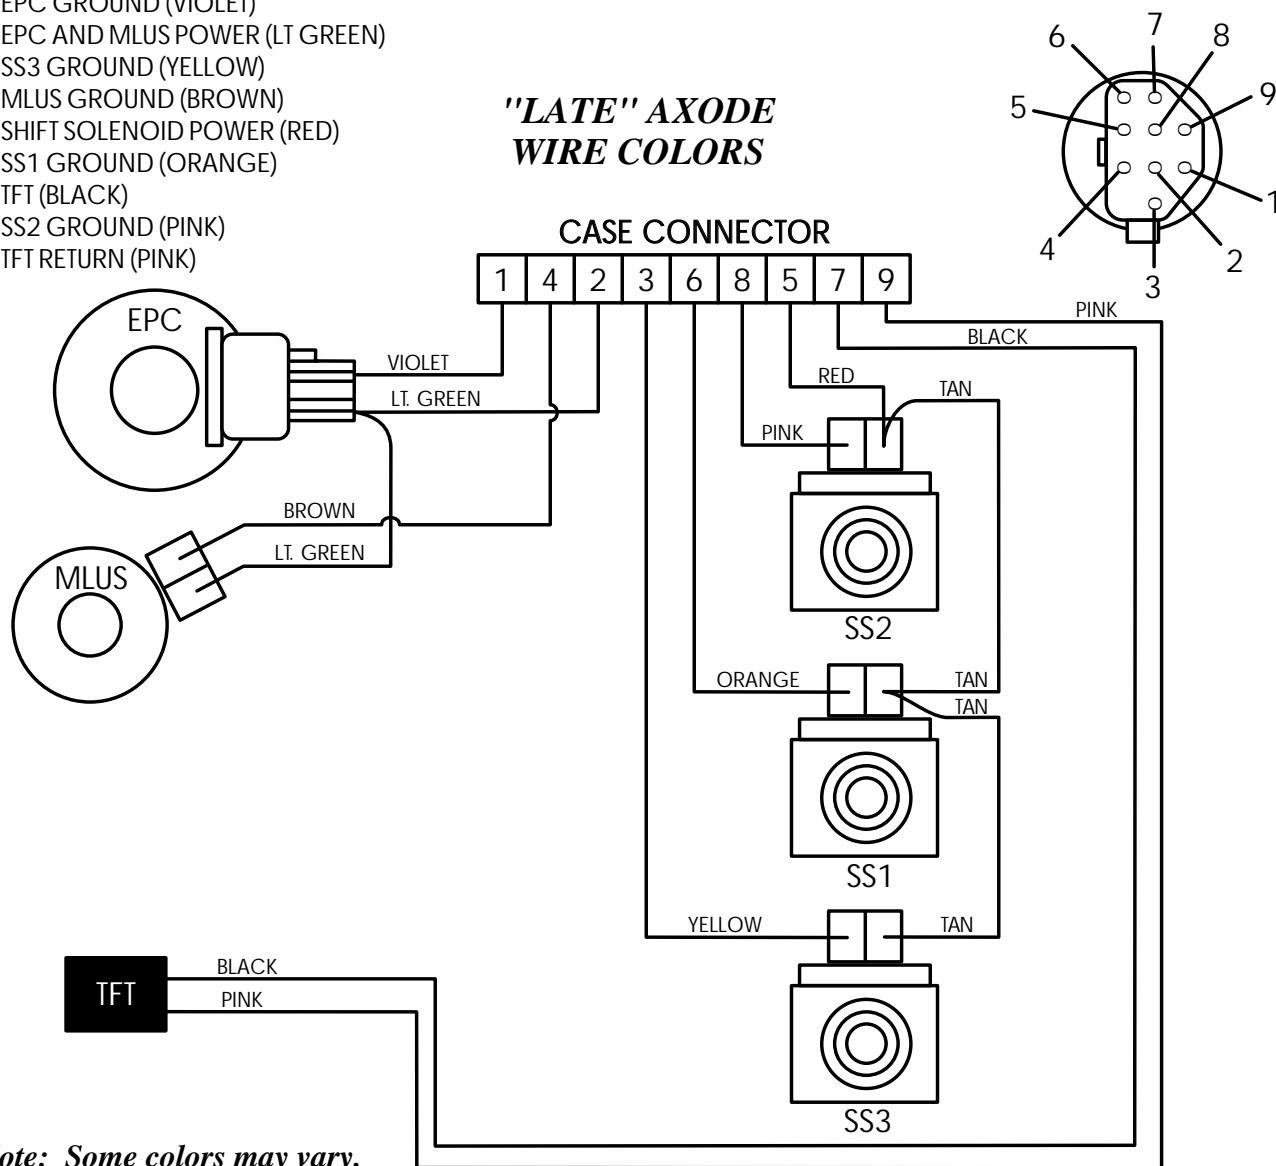
COMPLAINT: *After rebuild*, harsh shifts (High Line) and/or a "Clicking" or cycling noise may be heard from the side cover area, that is usually accompanied by an ON/OFF bind-up sensation that coincides with the "Clicking" noise. These symptoms may be accompanied with Diagnostic Trouble Code (DTC) 652 (MLUS Shorted or Open Circuit), DTC 624 (EPC Circuit Failure), and/or one Shift Solenoid DTC 621, 622, or 624.

CAUSE: The cause may be, solenoid wire connectors installed on the wrong solenoids.

**"LATE" AXODE
WIRE COLORS**

NOTE: The internal wire harness normally is secured by wire-ties which would prevent improper connection of solenoids, however, not all wire harnesses have the wire ties necessary to prevent this problem and the chart must be used.

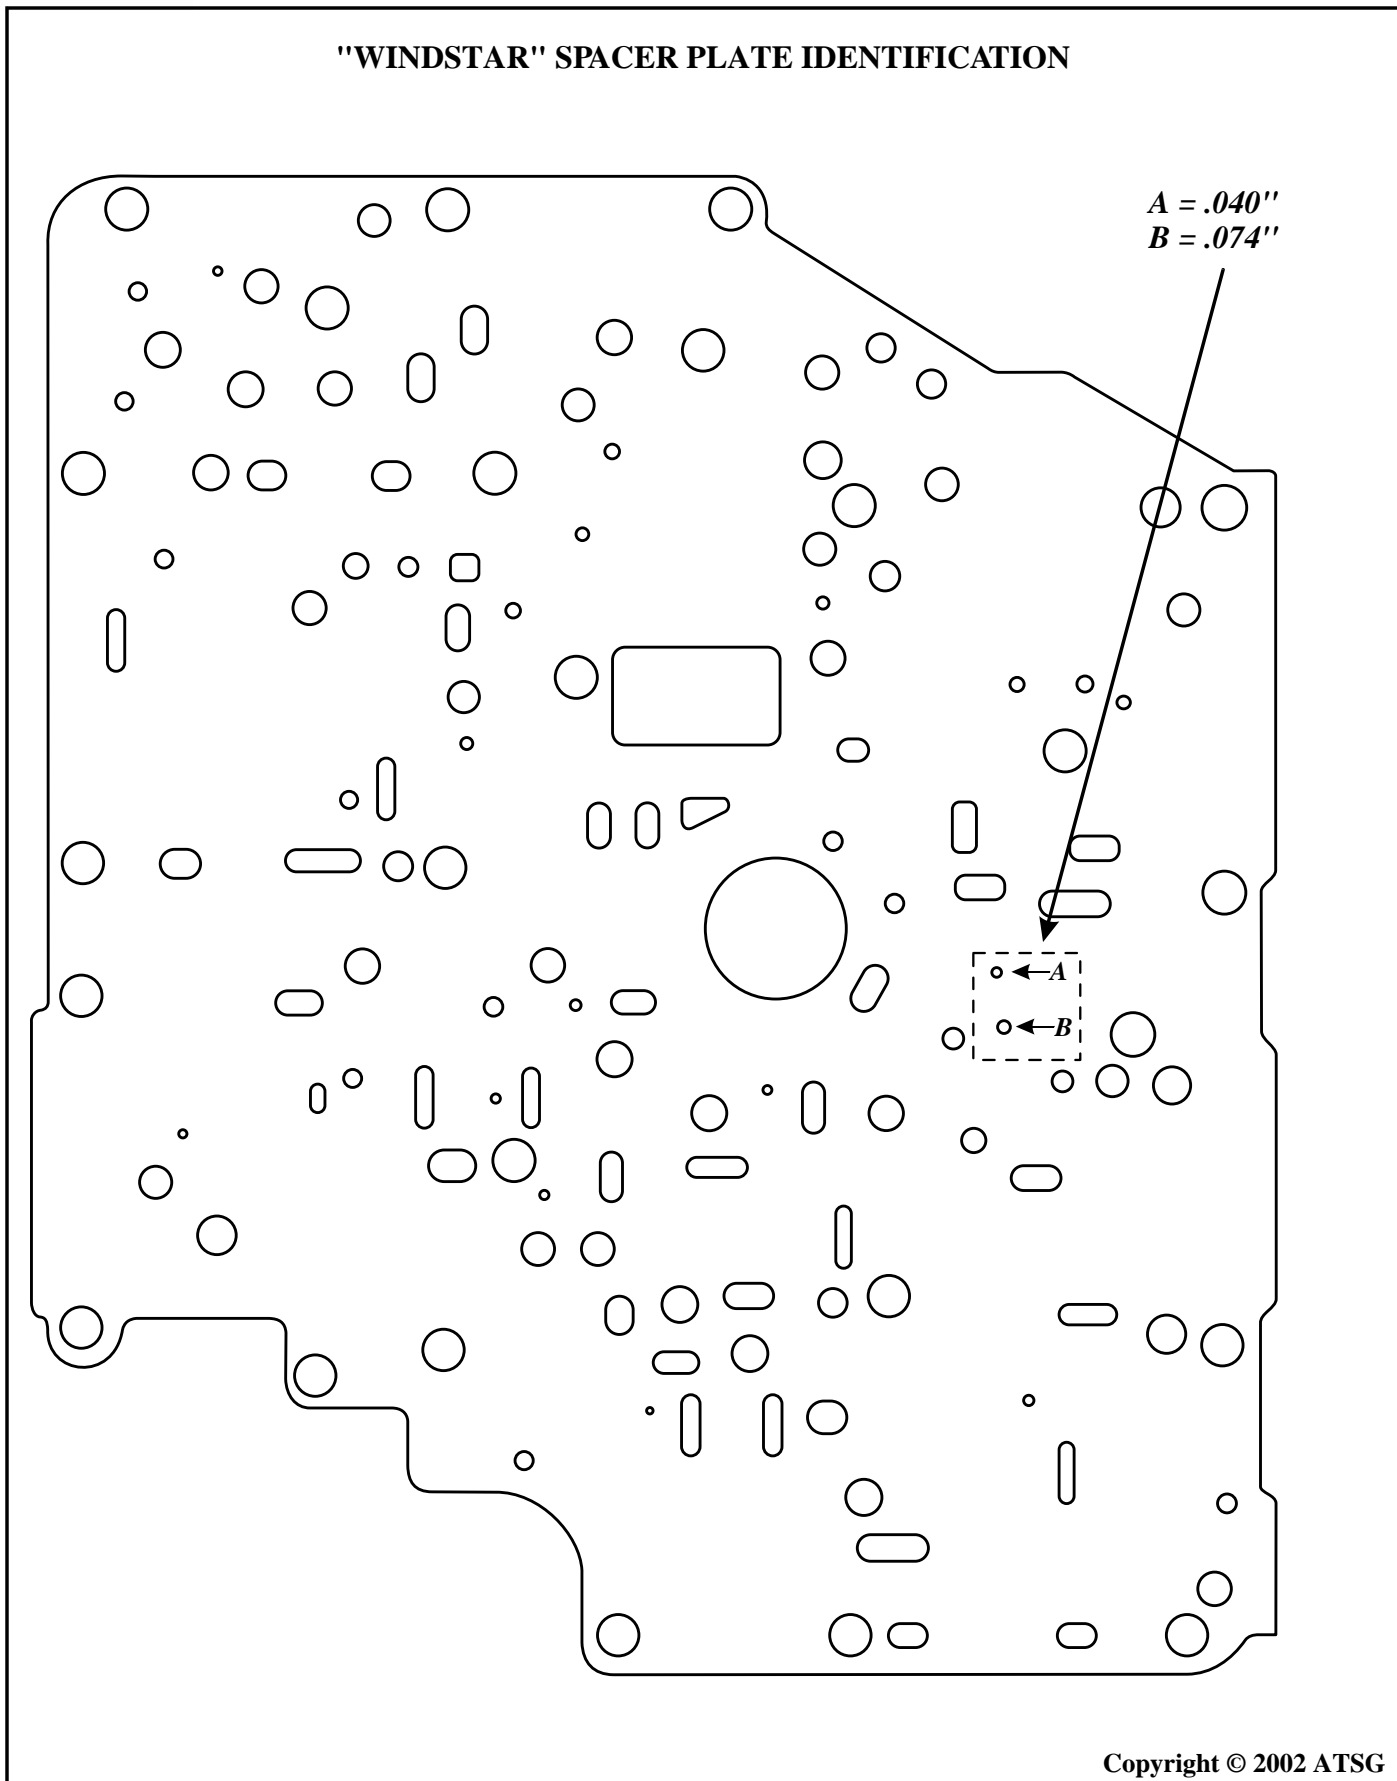
CAUSE: The cause may be, a valve body spacer plate designed for the Taurus, Sable, Continental passenger car family, has been installed on a Windstar Van, creating a harsh 1-2 upshift. If the Windstar Van valve body spacer plate, is installed on the Taurus, Sable, Continental family of vehicles, the result will be a soft or flared 1-2 upshift. ***Obviously these two spacer plates are different.*** Refer to Figures 101 and 102, using the two holes over the 1-2 capacity modulator valve area, for identification.

"WINDSTAR" SPACER PLATE IDENTIFICATION

CORRECTION: Install the proper valve body spacer plate for the Ford family that you happen to be servicing at this time. Refer to the illustration in Figure 101 to identify the valve body spacer plate for the Windstar Van. Refer to the illustration in Figure 102 to identify the valve body spacer plate for the Taurus, Sable and Continental family.
