AXOD/AXODE (AX4S) UPDATE HANDBOOK

Since the introduction of the Ford AXOD transaxle in model year 1986, there have been many major engineering design changes that have affected many of the parts used in the AXOD transaxle. This version of the AXOD "Update Handbook" begins with the 1986 model year and will explain each change, the parts affected by the change, and any parts interchange problems created by the change. This booklet is an updated version of the original.

This updated version of the AXOD "Update Handbook" will also cover the changes that occurred in the 1991 model year, when electronic controls were adapted to the AXOD transaxle, making it an AXODE, and now called an AX4S transaxle. We have included the changes on the AX4S transaxle up through and including model year 2002.

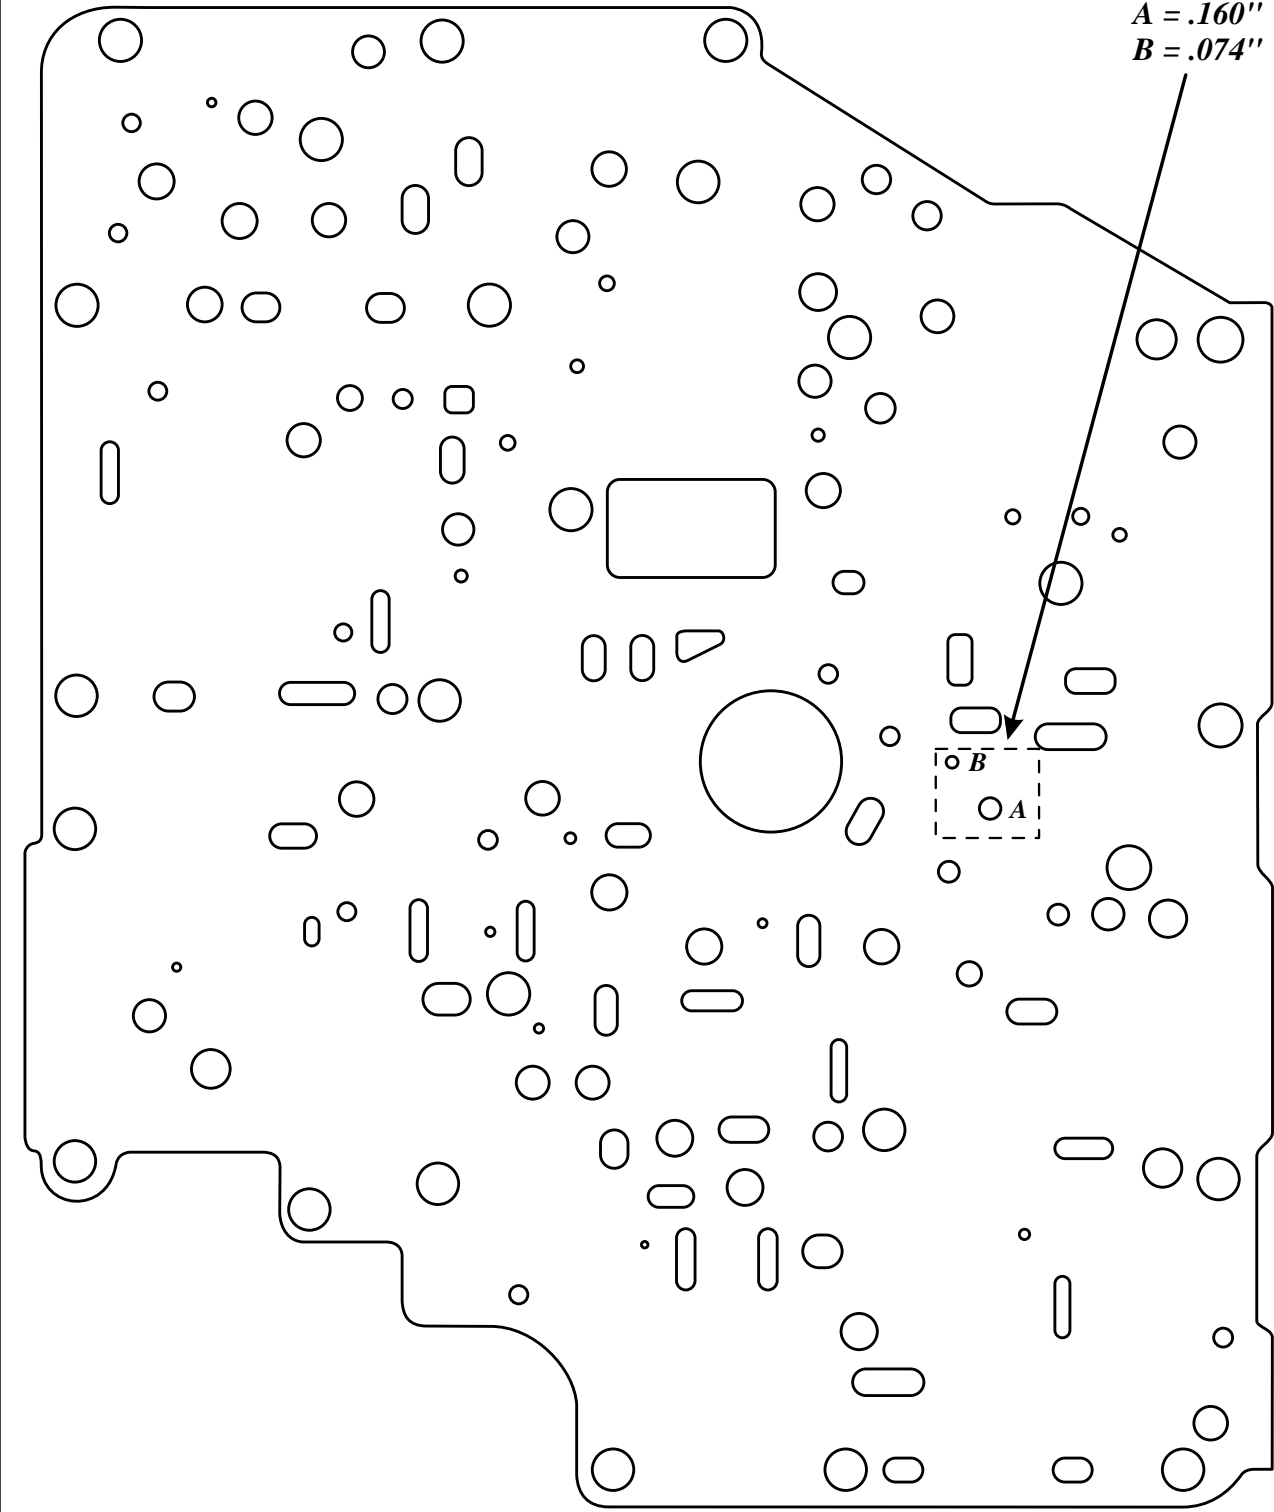
CAUSE: The cause may be, a valve body spacer plate designed for the Taurus, Sable, Continental passenger car family, has been installed on a Windstar Van, creating a harsh 1-2 upshift. If the Windstar Van valve body spacer plate, is installed on the Taurus, Sable, Continental family of vehicles, the result will be a soft or flared 1-2 upshift. ***Obviously these two spacer plates are different.*** Refer to Figures 101 and 102, using the two holes over the 1-2 capacity modulator valve area, for identification.

"TAURUS FAMILY" SPACER PLATE IDENTIFICATION

CORRECTION: Install the proper valve body spacer plate for the Ford family that you happen to be servicing at this time. Refer to the illustration in Figure 101 to identify the valve body spacer plate for the Windstar Van. Refer to the illustration in Figure 102 to identify the valve body spacer plate for the Taurus, Sable and Continental family.

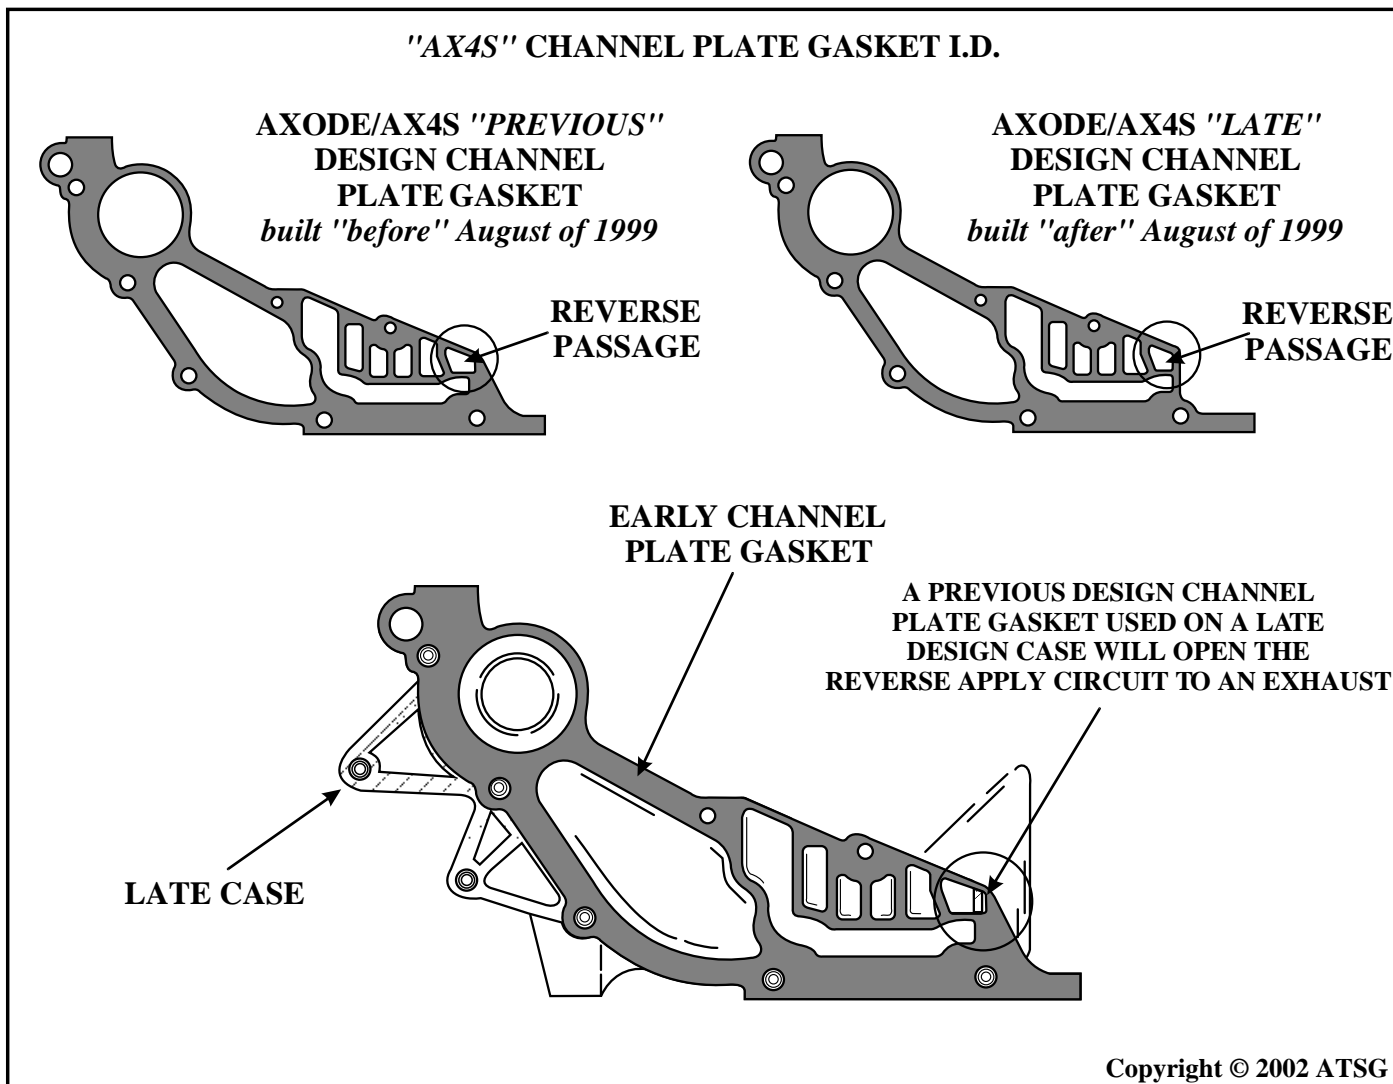
CAUSE: The cause may be, that the *Previous Design* Channel Plate Gasket, was used on a *Late Design* case as shown in Figure 103. When this happens, Reverse apply pressure will be exhausted back into the case because of the gasket hanging over the case casting.

CORRECTION: AX4S-Refer to Figure 103 to identify the correct Channel Plate Gasket for the application of vehicle you are working on.
AX4N-Refer to Figure 104 to identify the correct Channel Plate Gasket for the application of vehicle you are working on.

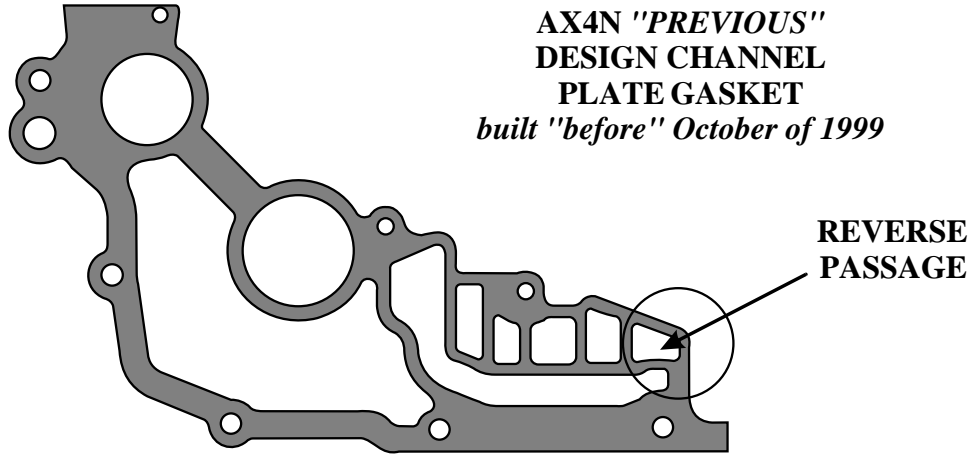
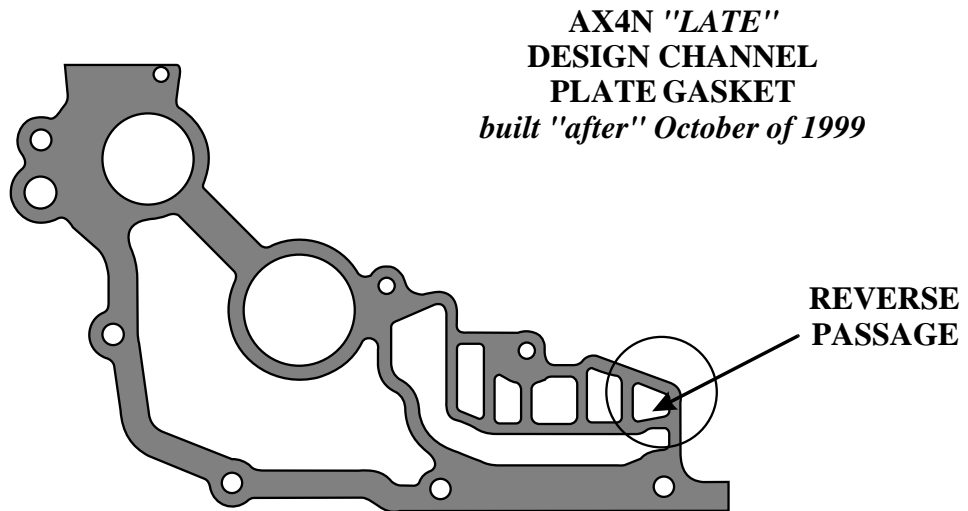
Figure 104

"AX4N" CHANNEL PLATE GASKET I.D.
